STATE HIGHWAY 9 WILDLIFE CROSSINGS MONITORING – YEAR 2 PROGRESS REPORT

December 2015 through April 2017

Study Number 115.01

March 2018

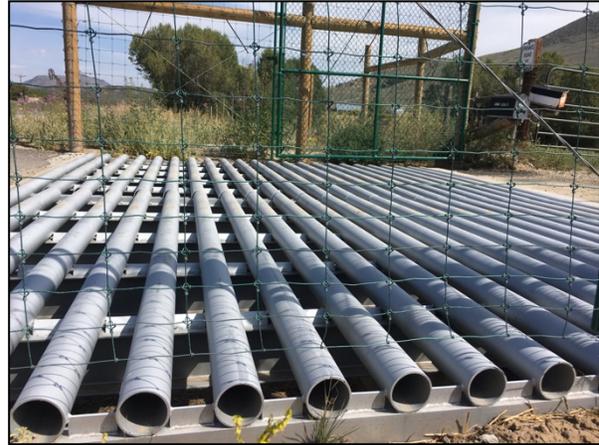
Figure 16. Round bar deer guard design installed at select locations during Phase 2 construction.

Snow plow damage has occurred at several of the flat bar guard locations. The round bar guards appear less susceptible to this type of damage. In addition, the flat bar design was more likely to get snow packed in between the bars during plowing, resulting in a continuous surface which can be more easily breached, as the photographic data displayed.

- **Deer guards.** Deer breaches observed in Phase 1 were hypothesized to be the result of 1) deer being able to easily walk on the flat bars, and 2) snow getting trapped between the flat bars and creating a packed surface for deer to walk across. As a result, CDOT developed a round bar guard design that was installed at three locations in Phase 2 and was used to replace the flat bar guards at two locations in Phase 1. Beginning in fall

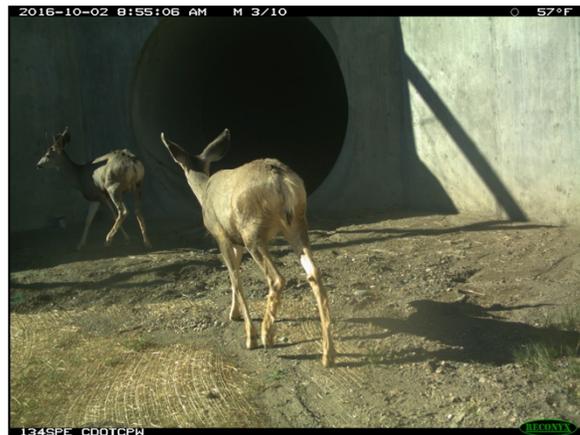
Figure 28. Mule deer repelling at the BVR Pipe Culvert.

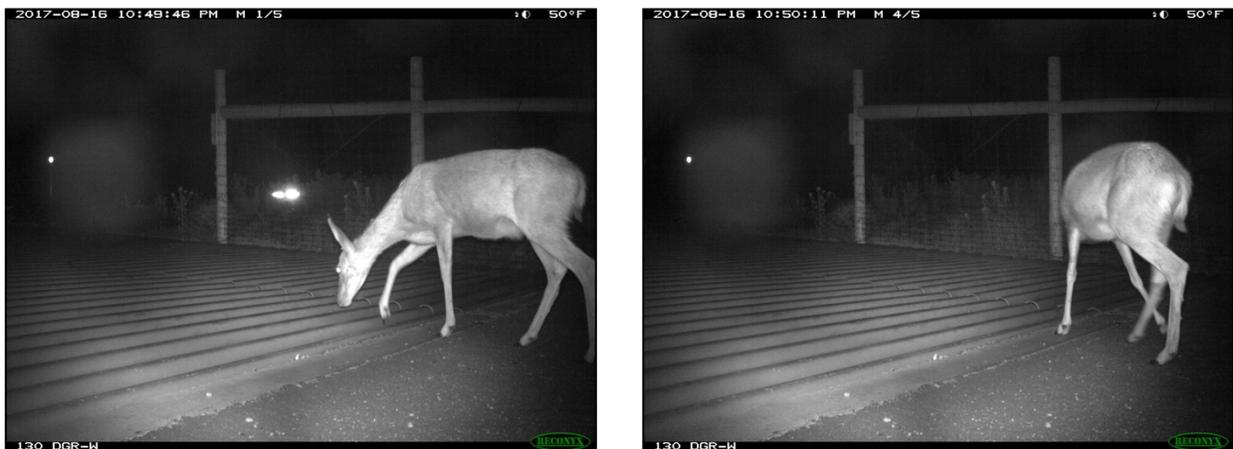
In general, deer guards deterred ungulates from entering the fenced right-of-way 77% of the time. Across monitoring locations, mule deer were most commonly photographed approaching the guards. The breach rate for mule deer at round bar guards was 13% compared to a breach rate of 29% for deer at flat bar guards (Fig. 29). Elk repelled from both types of guards at a rate of 85% (n=13). The only elk to approach to a round deer guard resulted in a breach, which it made by jumping rather than walking on top of the bars. Moose repelled from both guard types 100% of the time (n=6).

Figure 29. Mule deer approaching and ultimately repelling from the round deer guard at County Road 1002.

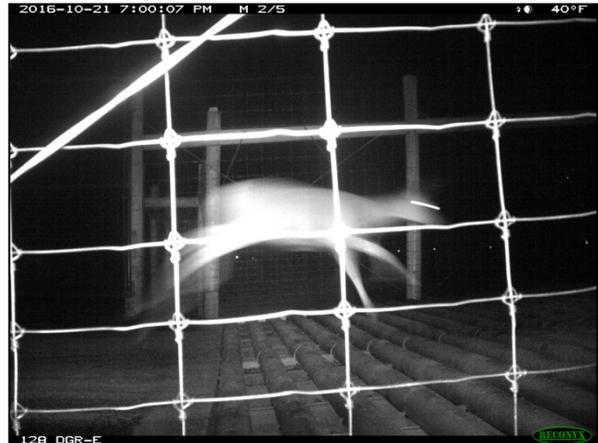
Figure 30. Mule deer jumping across the Triangle Road round bar deer guard.

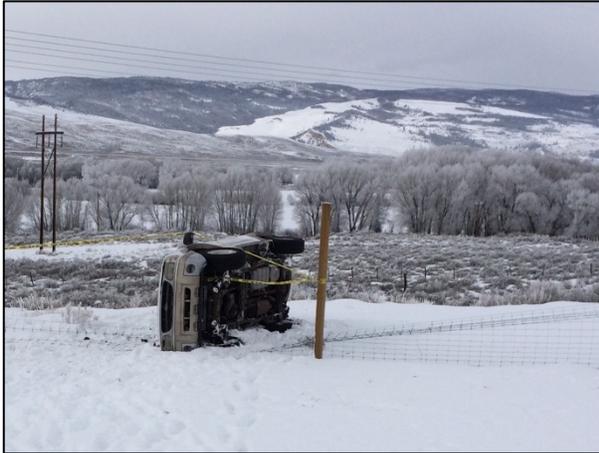
Wildlife exclusion fencing requires ongoing maintenance and a rapid response to fixing holes in the fencing to prevent wildlife incursions through gaps in the fence. Gaps may result from vehicles that run off the road (Fig. 33a), people that cut holes through the fence, wildlife damage, or normal wear and tear. In 2017, three cars ran off the road creating holes in the wildlife fence. Law enforcement, CPW and CDOT are called upon when wildlife incursions occur, requiring extensive labor on the part of these personnel to ensure that wildlife escape back to the habitat side of the fencing and are not involved in a WVC (Fig. 33b).

Figure 33. a) Gap in wildlife exclusion fence due to a vehicle that ran off the road (left). b) Mule deer exiting through a swing gate left open by CPW to allow the animal to safely exit the fenced right-of-way under their supervision (right).

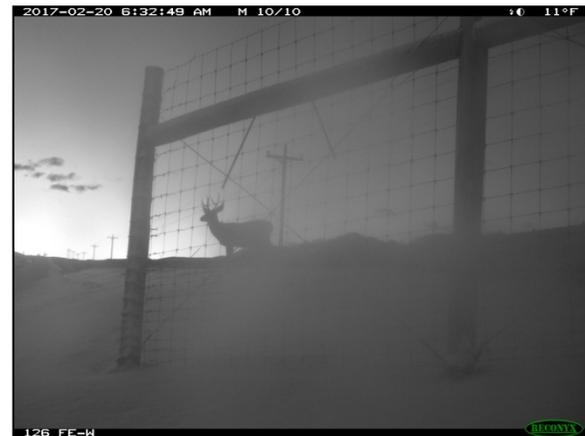
At the south fence end, the vast majority of ungulate movements occurred beyond the fence end (91.6%), that is animals that approached and potentially crossed the highway at-grade without entering into the fenced right-of-way (Fig. 34). Most of these movements were made by mule deer (n = 251), although elk were also photographed beyond the fence end (n = 22).

Figure 34. Mule deer buck moving beyond the south fence end.

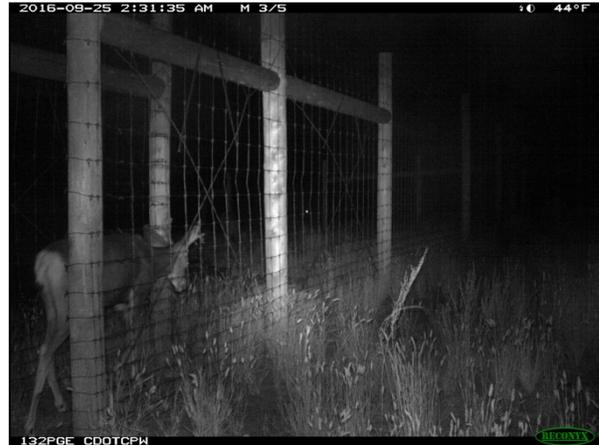
Breach rates for mule deer at pedestrian walk-through gates ranged from 5-21% across the three monitored pedestrian walk-through gate locations. Most mule deer breaches occurred at the Summit County Gate (n = 19), which had the widest opening. This location also captured the greatest number of deer movements (n = 176). The highest breach rate for mule deer, however, was at the BLM Gate (21%; n = 43), which, unlike other pedestrian walk-through gates,

Figure 35. Mule deer breach at the BLM Pedestrian Walk-through Gate.
