STATE HIGHWAY 9 WILDLIFE CROSSINGS MONITORING – PROGRESS REPORT

Phase 1 Pre-completion Monitoring

Study Number 115.01

February 2017

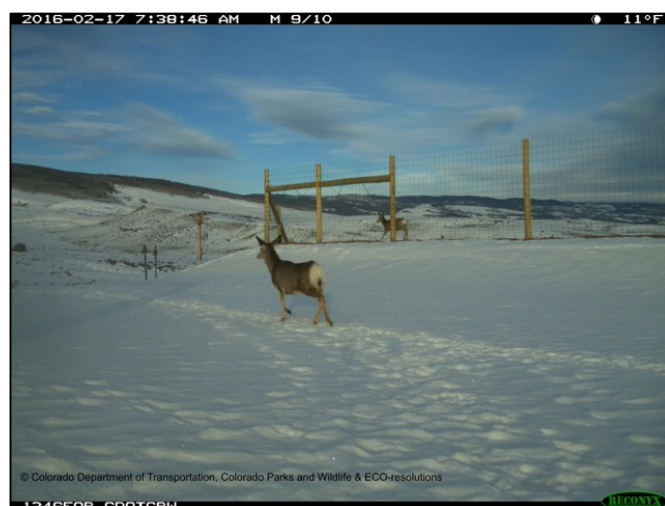
On several occasions mule deer were documented crossing over the North Overpass outside of the wildlife exclusion fence, along the structure edge. A gap in the wildlife fence between the fence and the edge of the structure was blocked with four-strand barbed wire fencing; however, camera monitoring documented that deer trapped in the right-of-way breached the barbed wire and crossed the overpass outside of the fence (Fig. 9).

Figure 9. Mule deer crossing over the North Overpass outside of the wildlife exclusion fence.

- **Fence gap on North Overpass.** To prevent mule deer from crossing the overpass outside of the wildlife fence, as documented by camera monitoring, the researchers recommended that the gap between the fence and the structure edge be closed with wildlife fencing. These fence gaps were closed during Phase 2 construction.

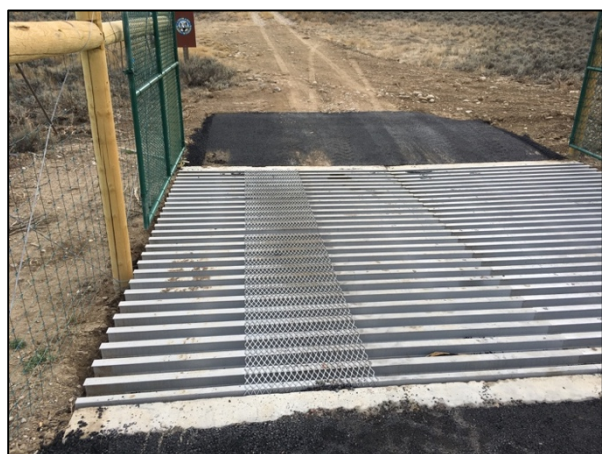
Figure 10. Example of a pedestrian grate across a deer guard.

the deer guards in Phase 1. Of these, 68 movements resulted in repels, while 38 times deer were recorded breaching the guard. Most breach movements were made by deer moving from the habitat side of the fence into the fenced right-of-way; however, breach movements were also documented of deer returning to the habitat side from the fenced right-of-way. Five such mule deer movements were captured at the County Road 33 deer guard; one at the Culbreath deer guard, and six at the Trough Road deer guard. Two guards had deer breach rates over 60% (County Rd 33 and Rusty Spur). Only one elk movement was recorded at the Thompson Deer Guard during this timeframe, and that movement resulted in a repel from the guard. Other species documented at the deer guards include badger, domestic cat, hare, raccoon and unknown. Most breach movements by all species were made by walking on top of the bars. On six occasions deer were recorded jumping across the guards. At Trough Road, deer breached the guards on seven occasions by walking across snow that was packed into the guard.

- **Deer guards.** Deer breaches observed in Phase 1 were hypothesized to be the result of 1) deer being able to easily walk on the flat bards, and 2) snow getting trapped between the flat bars and creating a packed surface for deer to walk across. As a result of these observations, CDOT developed a round-bar guard design that was installed at three locations in Phase 2 and was used to replace the flat-bar guards at two locations in Phase 1. This will enable the research team to study the relative effectiveness of the two designs in preventing incursions into the fenced right-of-way by deer and other wildlife
