State Highway 9 Wildlife Crossings Mitigation Monitoring

1. Report No. CDOT-2021-01		2. Government Accession No.		3. Recipient's Catalog No.	
4. Title and Subtitle State Highway 9 Wildlife Mitigation Monitoring				5. Report Date March 2021

16. Abstract This research monitored the effectiveness of a wildlife mitigation project on State Highway 9 in Grand County, Colorado. The purpose of the mitigation was to reduce wildlife-vehicle collisions (WVC) while providing permeability for wildlife across the highway. This five-year study used motion activated cameras and analyses of WVC crash and carcass data to evaluate mitigation effectiveness. The research documented 112,678 mule deer successful passages and a success rate of 96% across the seven structures. In addition to mule deer, sixteen other wildlife species successfully used the crossing structures. The wildlife crossings and fencing mitigation helped decrease WVC crashes by 92% and carcasses by 90% relative to preconstruction levels. Implementation Initial findings of the study were used to inform mitigation designs in the second construction phase, resulting in the addition of new escape ramp and wildlife guard designs. The fi

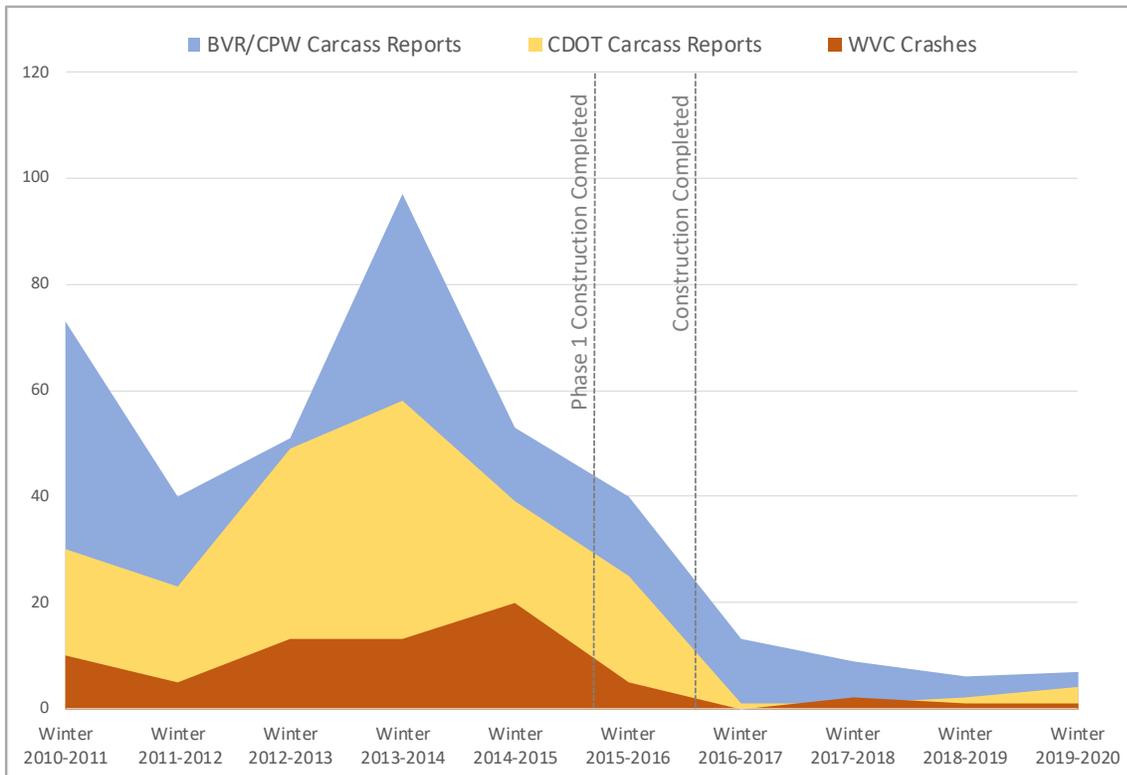
Figure E-1. Pre- and post construction WVC carcasses and crashes reported each winter as documented by BVR/CPW carcass reports, CDOT carcass reports, and CDOT crash reports. Mule deer activity and, correspondingly, WVC are highest during the winter months (November – April), which were the focus of the BVR/CPW carcass reporting effort.

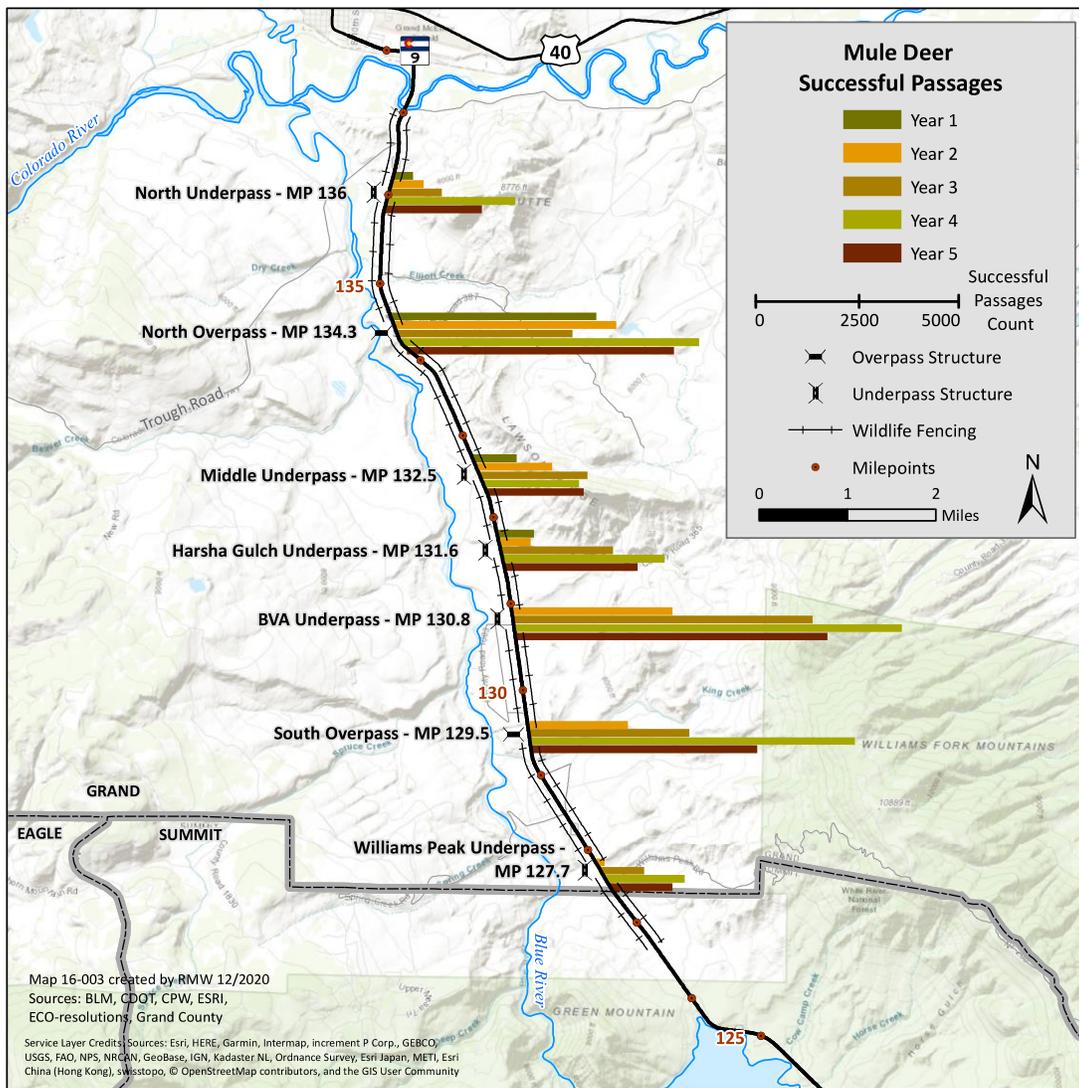
Figure E-2. Mule deer successful passages by study year at each crossing structure location. In total, the study documented 112,678 successful passages by mule deer.

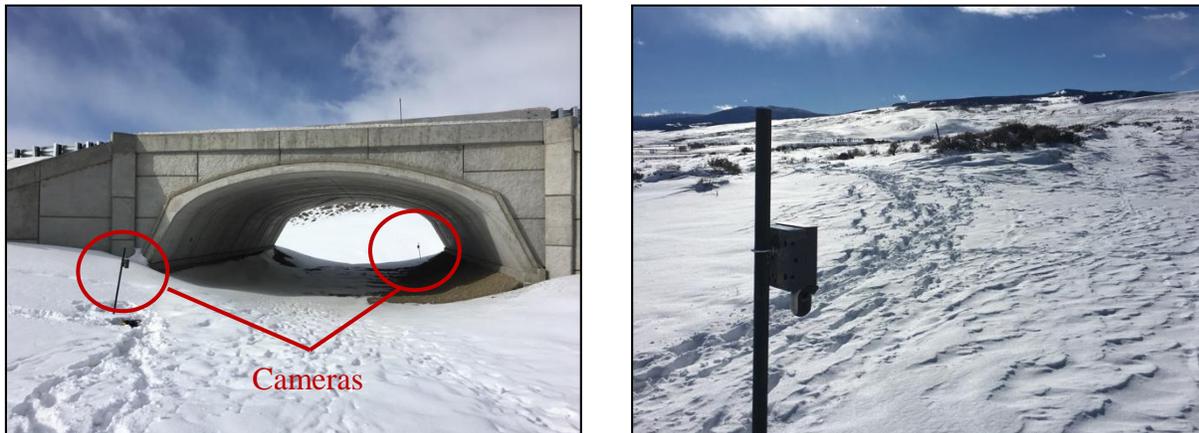
Figure 2-1. Two cameras were positioned at each underpass at opposite corners (left). Habitat camera placed 50-100 feet away from a structure, facing out into the adjacent habitat (right).

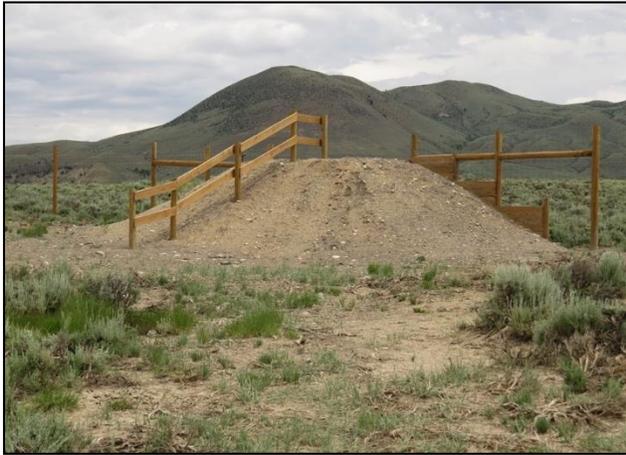
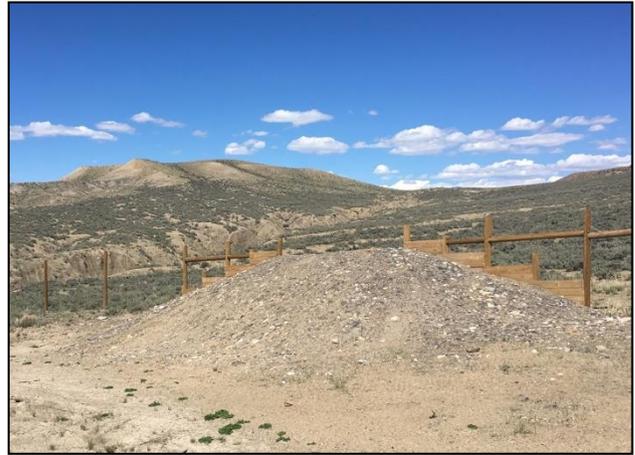
Figure 2-2. Example of an escape ramp with a 2:1 slope with perpendicular rail fence (left) and a ramp with a 3:1 slope without rail fence (right).

Two cameras were set up at each monitored escape ramp, one at the base of the ramp in the right-of-way (ROW) to capture wildlife approaching the ramp or walking around the ramp; and one on the fence line looking across the top of the ramp to capture wildlife behavior at the top of the ramp, including successful escapes as well as jump up attempts from the habitat side onto the ramp. Throughout the study period, 13 escape ramps were monitored for varying lengths of time. In the Phase 1 (north) segment, all ramps were constructed with a 2:1 slope and perpendicular rail fence, except for the North Overpass Escape Ramp, which did not have rail fence. Based on preliminary data, observations, and recommendations by the research team, in Phase 2 construction, all ramps were built with a 3:1 slope instead of a 2:1 slope (Fig. 2-2). In general, ramps were constructed with perpendicular rail fence, except for select locations where rail fence was omitted per the request of the researchers who wanted to evaluate the effectiveness of ramps with and without perpendicular rail fence. In addition, two new 3:1 slope escape ramps were constructed in the Phase 1 segment near existing 2:1 slope ramps. These two ramps were situated at lower topographic positions relative to the roadway, while the nearby 2:1 slope ramps were situated above the roadway. All of the ramps built in both construction phases were designed to be six feet high at the jumping off point, with a 16' wide fence gap; actual ramp heights range from 65 to 88 inches (5'5" to 7'4"). Over the course of the study, 13 escape ramps were

monitored for varying lengths of time including four 2:1 slope ramps with rail fence, one 2:1 slope ramp without rail fence; two 3:1 slope ramps with rail fence; five 3:1 slope ramps without rail fence; and one jump down.

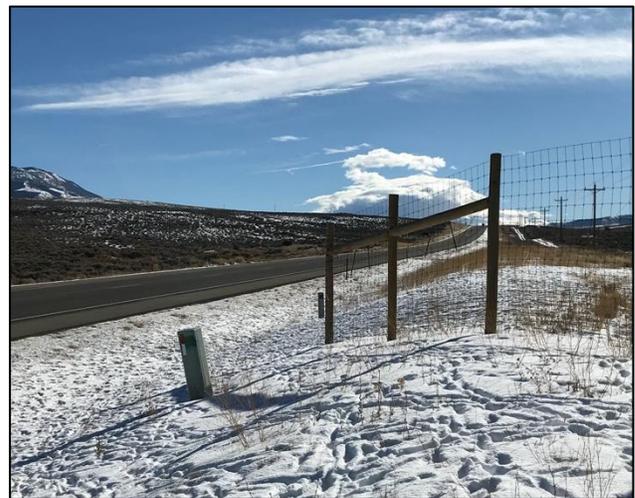
Figure 2-3. Cameras encased in utility boxes at the south fence end.

Wildlife exclusion fence runs along the right-of-way line throughout the project area. The northern terminus ties into the Colorado River Bridge south of Kremmling. The southern terminus is at MP 126.7. At this fence end, the fence line angled in towards the highway, ending 20' from the pavement edge so that it was not inside the clear zone. At the south fence end (Fig. 2-3), cameras were positioned to capture wildlife movements into and out of the fenced right-of way, as well as movements that occurred beyond the fence end.

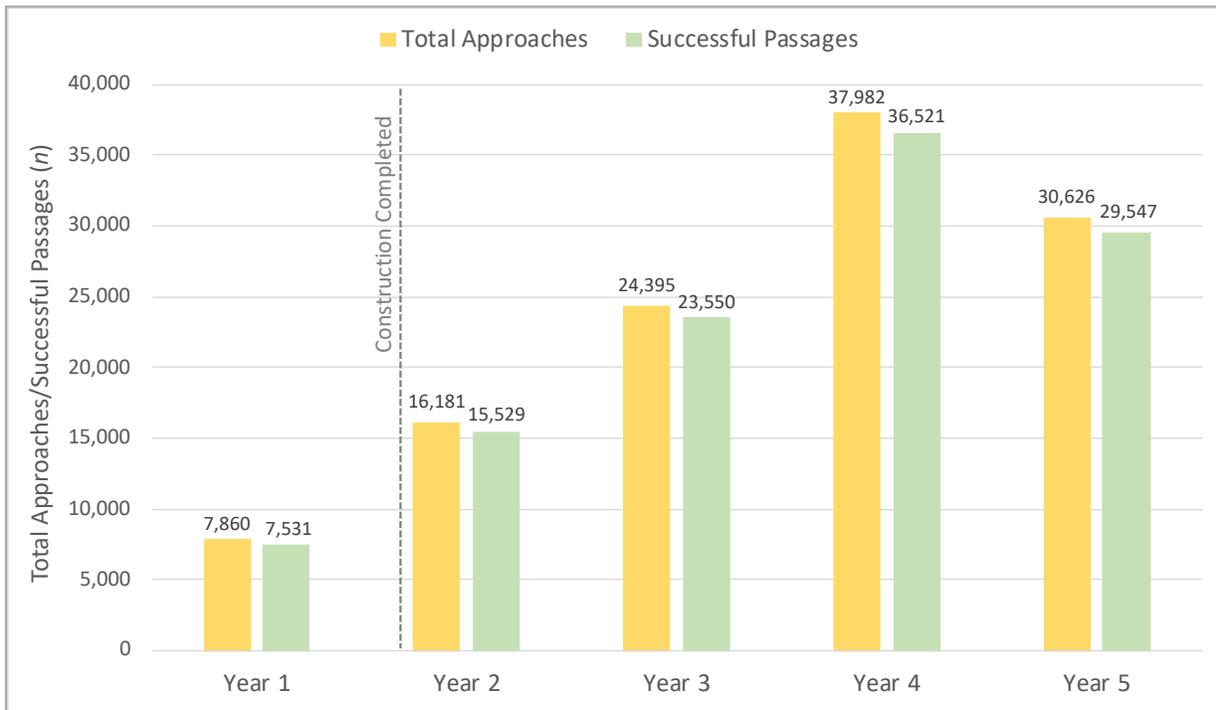
Figure 3-1. Total number of mule deer approaches and successful passages at the seven wildlife crossing structures each year of the study. For each year, the closer the yellow and green bars are in height, the higher the success rate. Four crossing structures were monitored in Year 1. Construction was completed at the end of Summer of Year 2, marking the onset of post construction monitoring at all seven crossing locations.

Year 2 data primarily reflect winter movements. Ongoing construction during the summer months resulted in a temporary cessation of monitoring activities at several locations in the Phase 1 portion of the project area and crossing structures in the Phase 2 portion of the project area were still under construction. While the total number of mule deer approaches and successful passages was lowest during the Construction Phase (Winter of Year 1 through Summer of Year 2), mule deer made 9,173 successful passages during this timeframe (7,531 in Year 1 and 1,642 in Summer of Year 2) with a success rate of 96%.

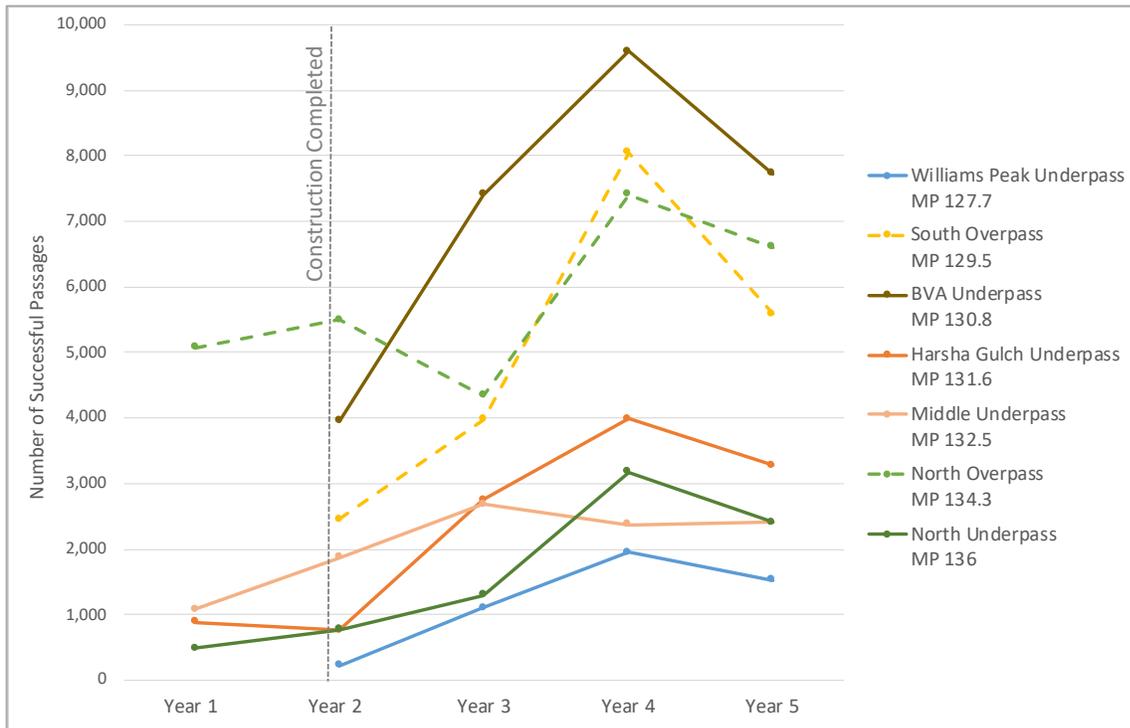
Figure 3-2. Annual number of mule deer successful passages at each crossing structure each year of the five-year study.

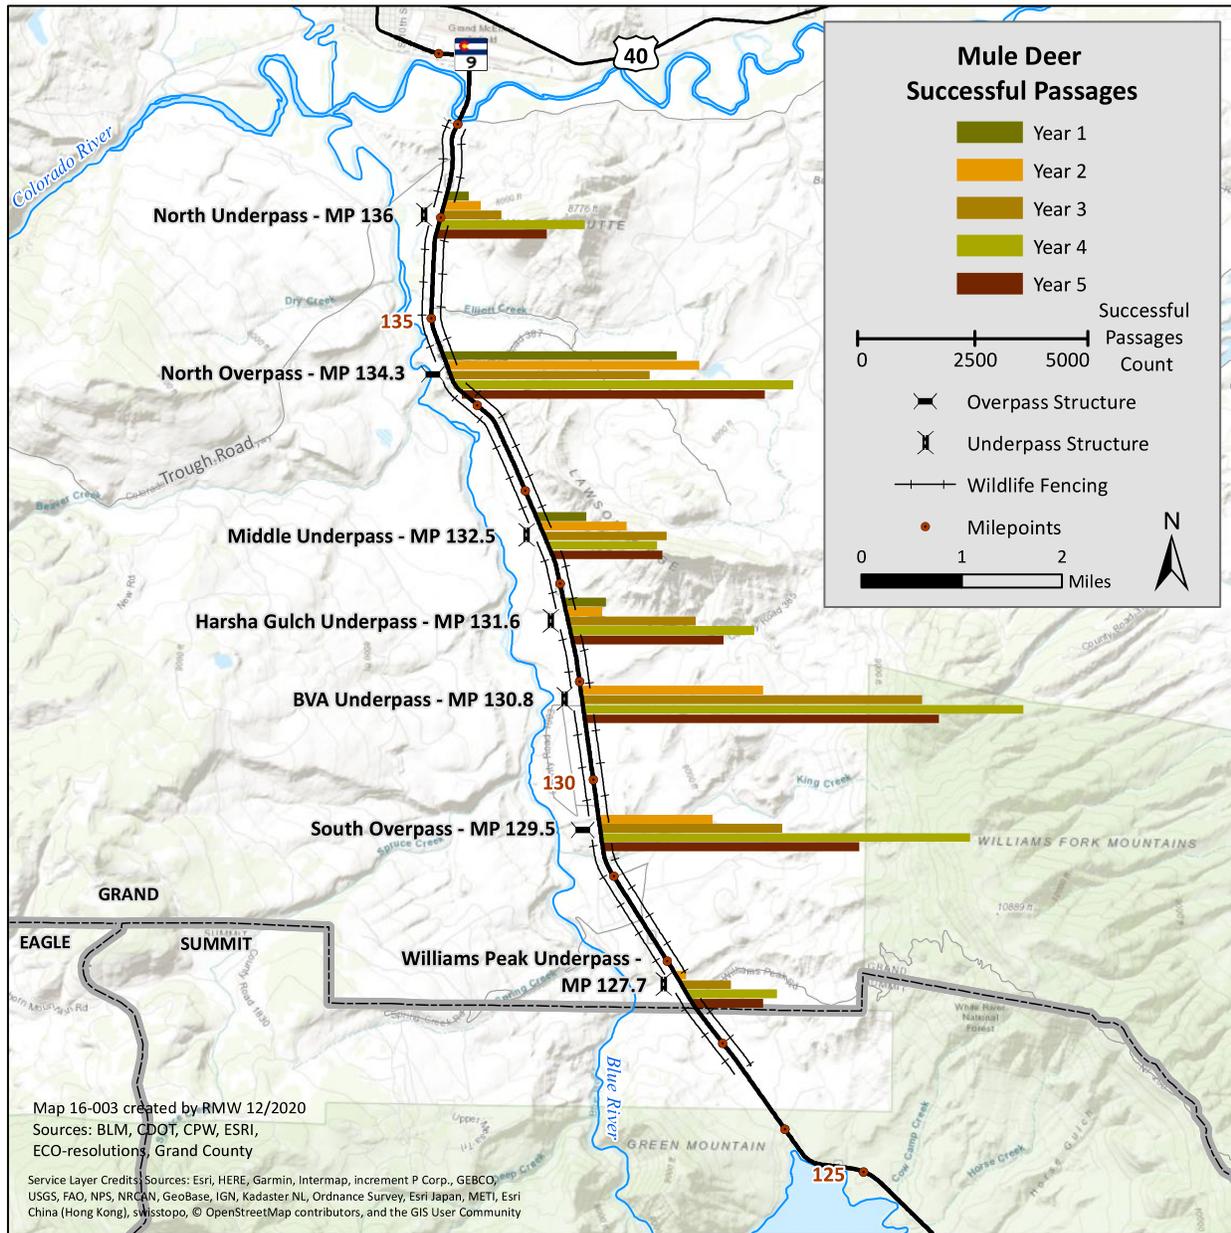
Figure 3-3. Mule deer successful passages by study year at each crossing structure location.

successful passages. Figure 3-3 plots the annual number of successful passages by location to demonstrate the spatial distribution of mule deer activity at the crossing structures. Detailed results from each crossing structure location are presented in Appendix D.

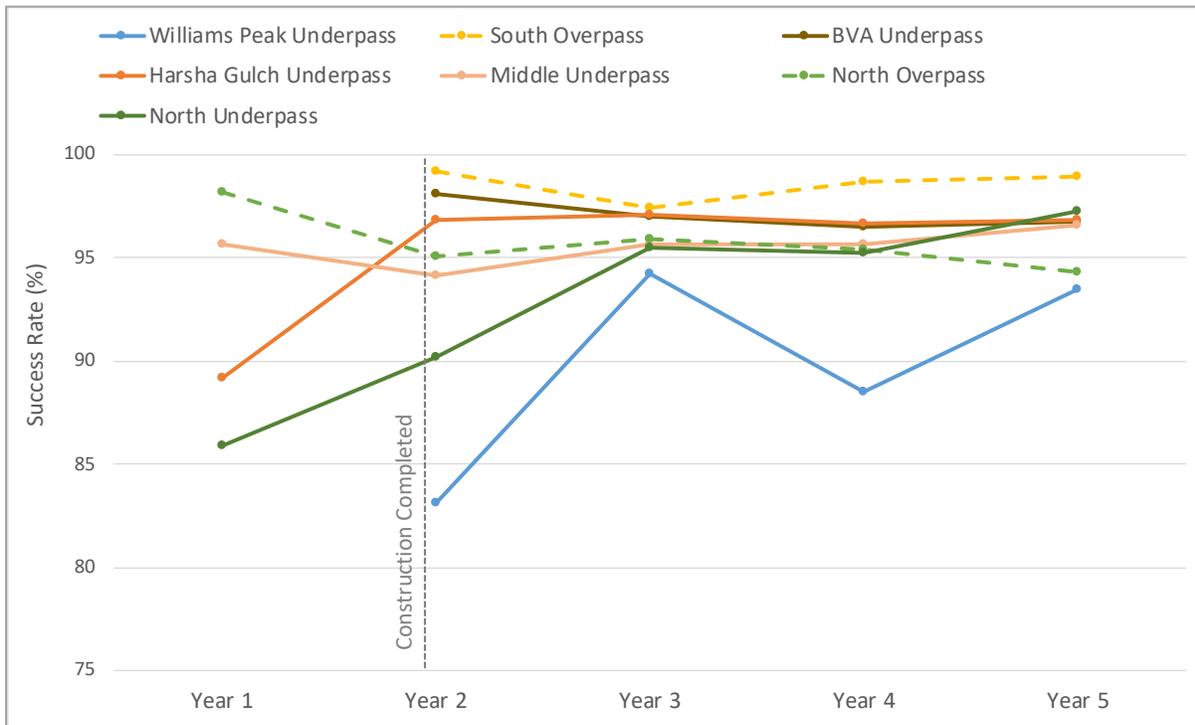
Figure 3-4. Mule Deer success rates at each of the crossing structures each year of the study.

The overall success rate for mule deer across all of the crossing structures was 96%. Success rates ranged from 83% (Williams Peak Underpass, Year 1) to 99% (South Overpass, Years 2, 4 & 5), and tended to increase over time at each crossing location (Fig. 3-4). In the final year of the study mule deer success rates ranged from 94% to 99%. While a small decrease in success rate was observed at the North Overpass in Year 5, this decrease was not significant, and across all years of the study the success rate at this location was 94% or greater. Both overpasses, the BVA Underpass, and the Middle Underpass had success rates around 95% or higher throughout the time that they were monitored. At the remaining underpass structures, success rates were lowest in the first year of monitoring and increased in the second year. The greatest variability in success rate was observed at the Williams Peak Underpass, which had the highest repel rate (7.5%). The number of parallel movements relative to the total number of approaches was greatest at the North Underpass, the Middle Underpass, and the BVA Underpass. In general, parallel movements represented a small proportion of the overall activity at the crossing structures.

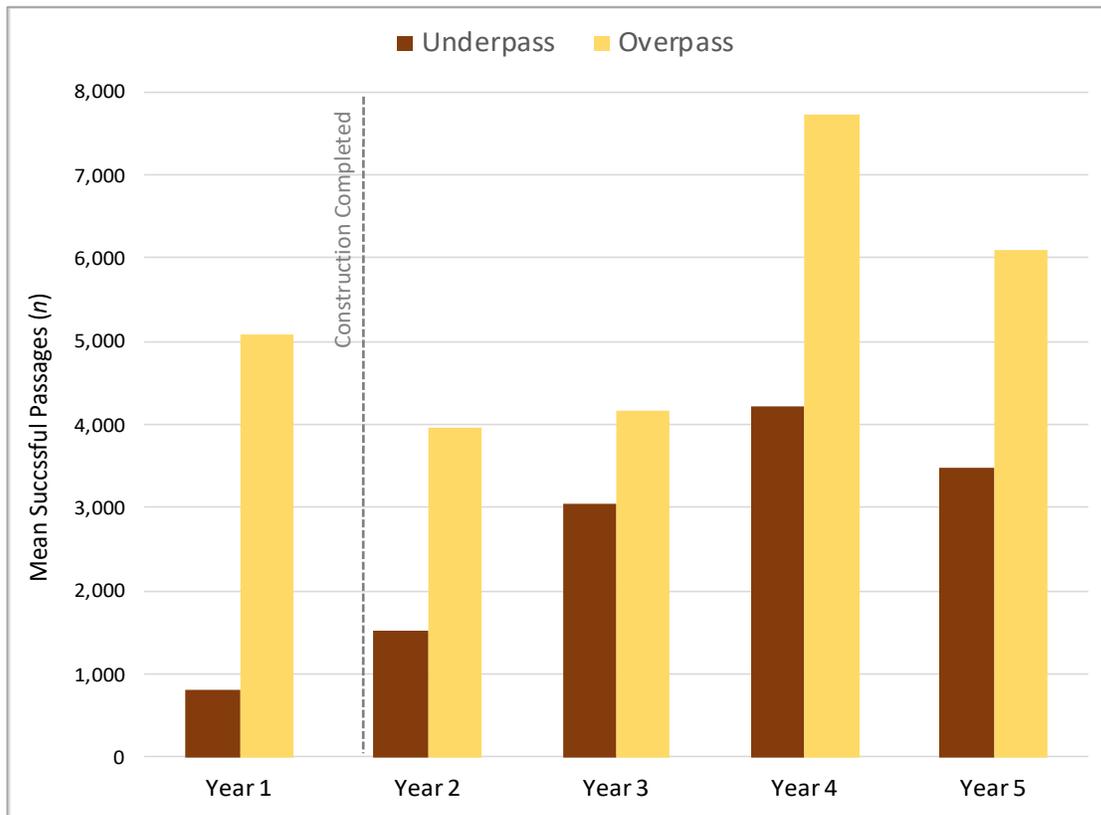
Figure 3-5. Annual number of mule deer successful passages standardized by the number of overpasses (n=2) and underpasses (n=5). Only one overpass and three underpasses were constructed and monitored in Year 1 through the end of Summer Year 2 when construction was completed.

Total Successful Passages	Annual Average # Successful Passages	Post construction Monitoring Days	Average # Successful Passages <i>per Structure</i> per Monitoring Day
Overpasses (n=2)	48,972	9,794	2,845	8.6
Underpasses (n=5)	63,706	12,741	7,010	1.8

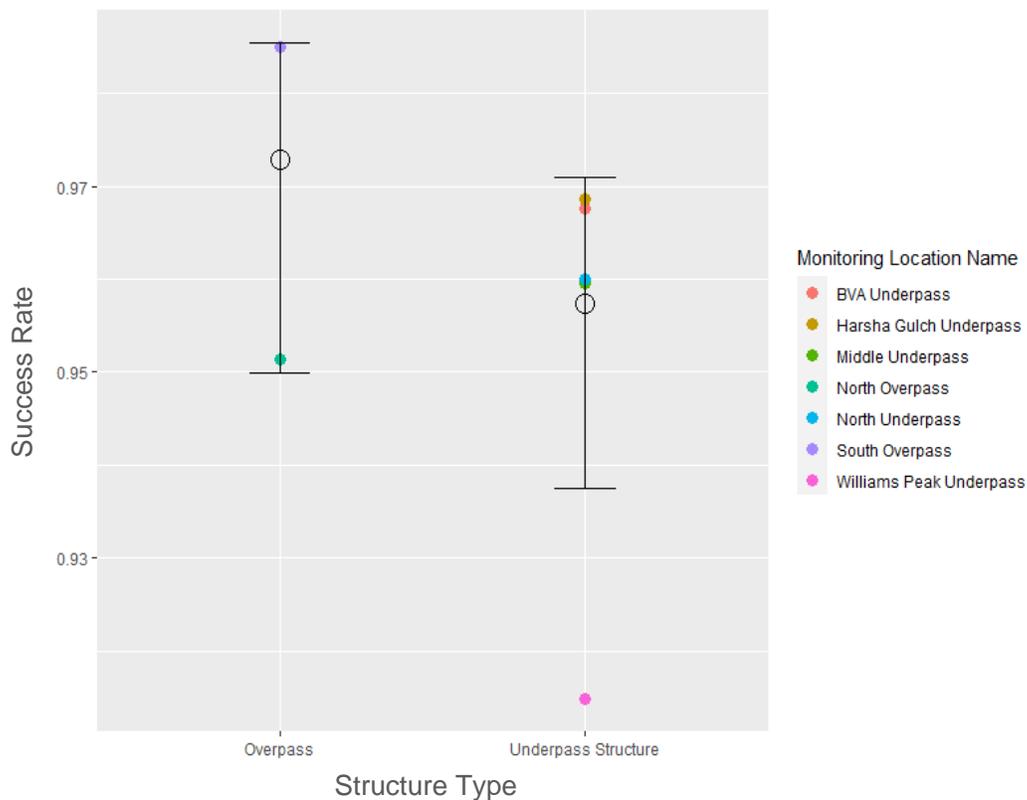
Figure 3-6. Mean mule deer success rate (open circle) and standard deviation by crossing structure type.

Statistical investigations into the differences in success rates between overpasses and underpasses were conducted. An analysis of deviance (Type II Wald chi square tests) of the overall post construction mean success rate for overpasses (97%) was not shown to be different from the mean success rate of underpasses (96%; $p=0.233$; Fig. 3-6). A gender-based preference for overpasses or underpasses based on buck and doe success rates could not be determined, but in the final three years of the study, bucks and does used overpasses (55% and 65%, respectively) more than underpasses.

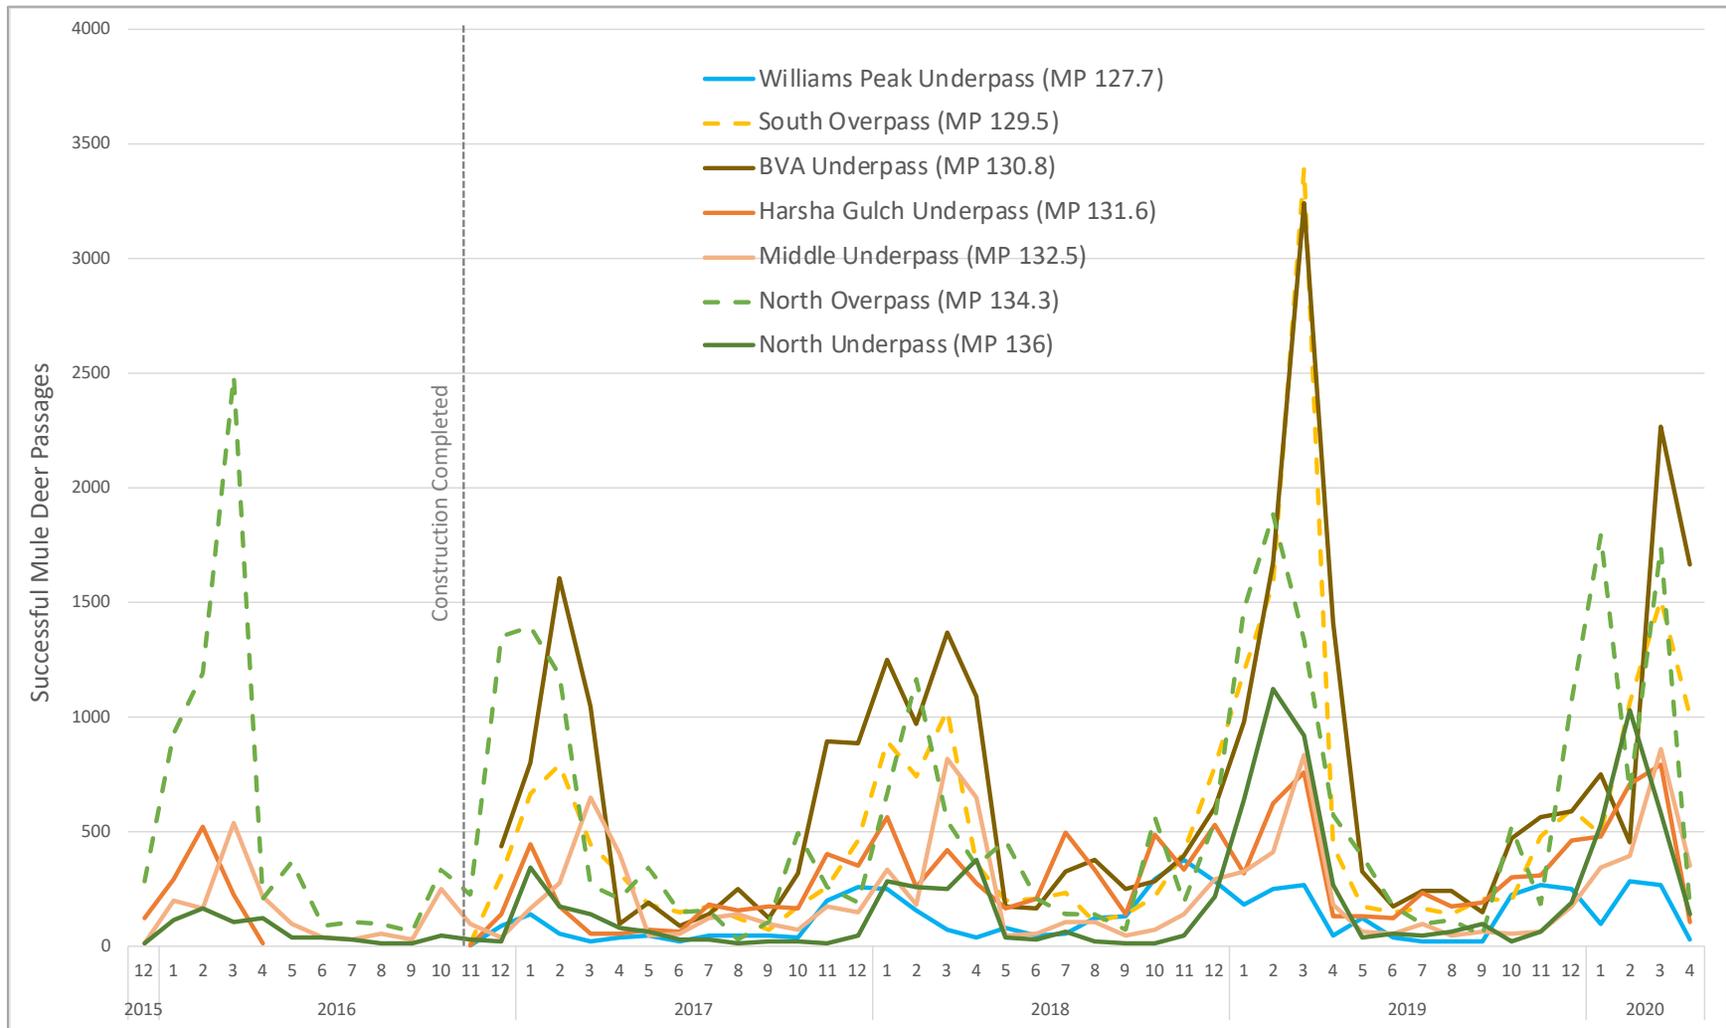
Figure 3-7. Mule deer successful passages by month and year at each of the wildlife crossing structures over the five-year study period.

Successful passages by mule deer at the wildlife crossing structures were plotted for each month from the onset of the camera monitoring in December 2015 through April 2020 (Fig. 3-7). Periods of peak mule deer use differed at each crossing structure location and varied from one year to the next. In general, mule deer numbers began increasing in October as migratory herds arrived on winter range and decreased in April as these herds moved out of the study area onto summer range. Mule deer activity generally peaked in February or March at all crossing structures, although the timing of these peaks varied from year to year and by location. Winter 2018-19 saw the greatest number of successful passages at all of the crossing structures except the Middle Underpass where the number of successful passages decreased slightly (-7%).

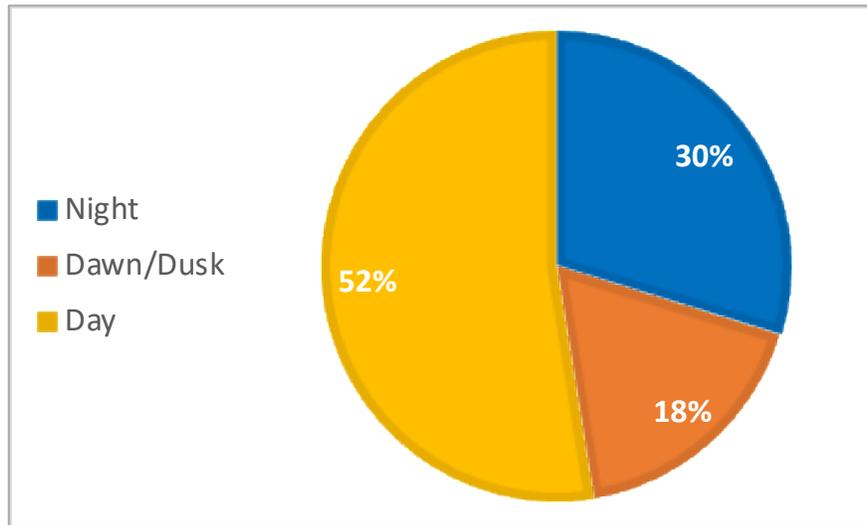
Figure 3-9. Mule deer successful passages at the crossing structures by time of day.

Over half of all mule deer successful passages at the crossing structures occurred during daylight hours (Fig. 3-9), although the research team noted that many daytime movements occurred early or late in the day.

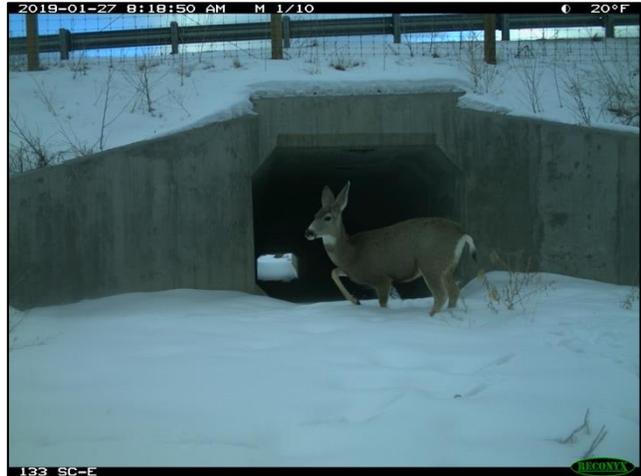
Figure 3-11. Mule deer repelling at the BVR Box Culvert.

Three small culverts (6-8' openings) were monitored for varying lengths of time. The small culverts were located between the crossing structures. The distance to the nearest crossing structure from the Culbreath Box, the BVR Pipe Culvert and the BVR Box Culvert was 0.8, 0.1, and 0.5 miles, respectively. Few mule deer approaches ($n=369$) were recorded at the small culverts compared to the large crossing structures. While mule deer were documented passing through each of the small culverts (total number of successful passages = 103), the average number of mule deer successful passages per monitoring day was 0.05, which equates to one successful passage for every 20 monitoring days across the three small culvert locations. The highest number of successful passages was documented at the BVR Box Culvert ($n=96$; MP 133); fewer than five passages were recorded at each of the other two culvert locations (Fig. 3-11).

The majority of mule deer approaches to the small culverts resulted in a repel ($n=142$) or parallel movement ($n=124$). The success rate for mule deer at small culverts was 28%, the repel rate was 39%, and the parallel rate was 34%. The highest mule deer repel rate at the small culverts was documented at the Culbreath Box Culvert (67.6%). This small culvert location was also the only one where domestic animals were documented, including cats ($n=21$) and dogs ($n=9$).

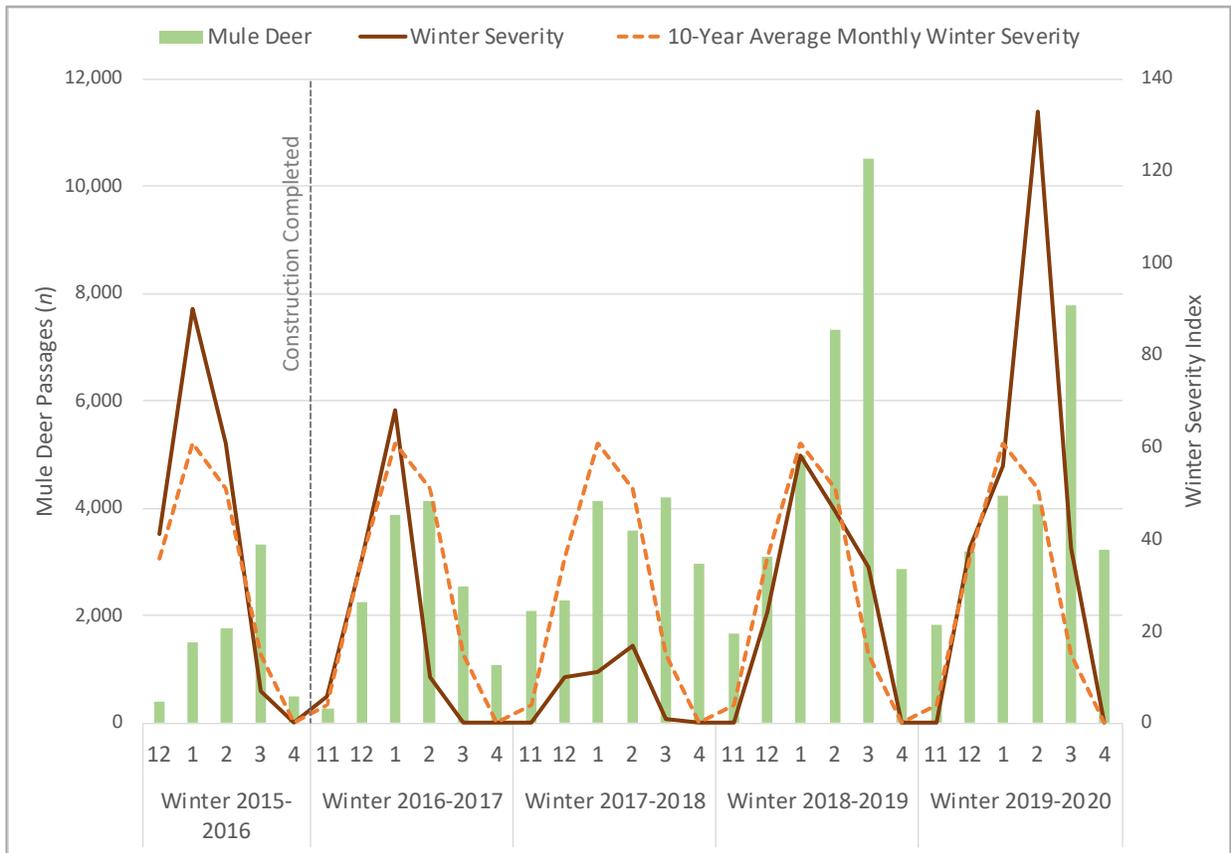
Figure 3-14. Comparison of mule deer successful passages, annual winter severity, and the ten-year average winter severity by winter month (November through April). Winter severity is an index based on weekly temperatures and snow depth.

The number of mule deer successful passages per winter month was analyzed with respect to monthly winter severity to help illuminate if there was a relationship between mule deer successful passages and snow depth and temperatures. CPW’s winter severity index was based on weekly measurements of temperature and snow depth at established transects (Birch 2020). The weekly indices were averaged by month for comparison to monthly winter mule deer passages at crossing structure (Fig. 3-14). A range of winter conditions were observed following the completion of construction activities, including two average winters (Winters 2016-2017 and 2018-2019), one mild winter (Winter 2017-2018), and one severe winter (Winter 2019-2020). In general, the month with the most severe winter conditions (January/February) was followed by the month with the highest number of mule deer passages. The number of mule deer passages (Fig. 3-15) peaked in Winter 2018-2019, while winter severity peaked in Winter 2019-2020, during which there was a relative decrease in the number of mule deer movements.

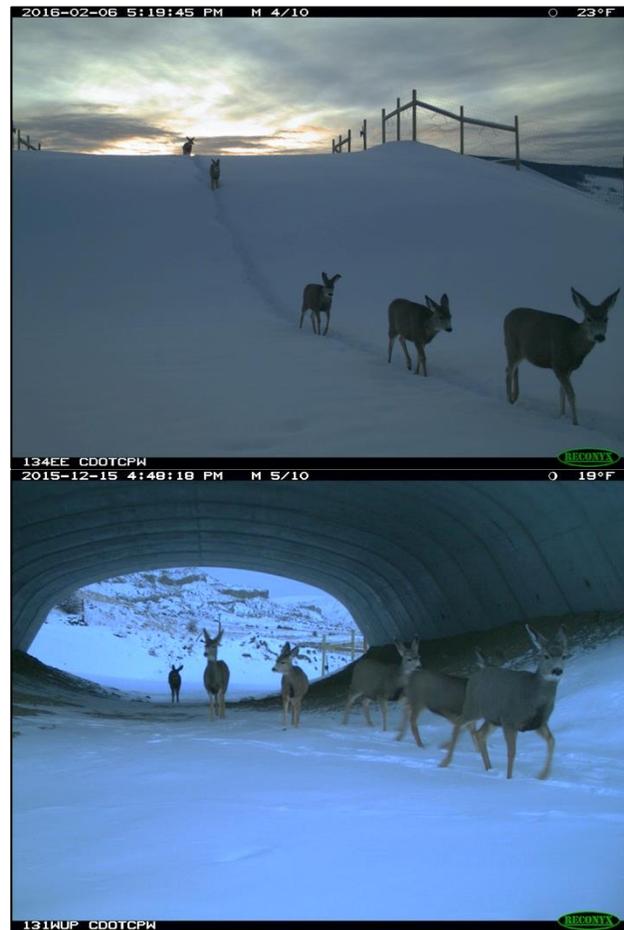
Figure 3-19. Mule deer on the North Overpass (top) and at the Harsha Gulch Underpass (bottom).

Statistical analyses of mule deer abundance and successful passages in relation to structure type could not detect a discernable preference for one structure type over the other and both underpasses and overpasses functioned well for mule deer (Fig. 3-19). These results likely reflected variations in mule deer winter range habitat use – that is, structures located in portions of the winter range with the greatest density of mule deer receive the most use, regardless of structure type.

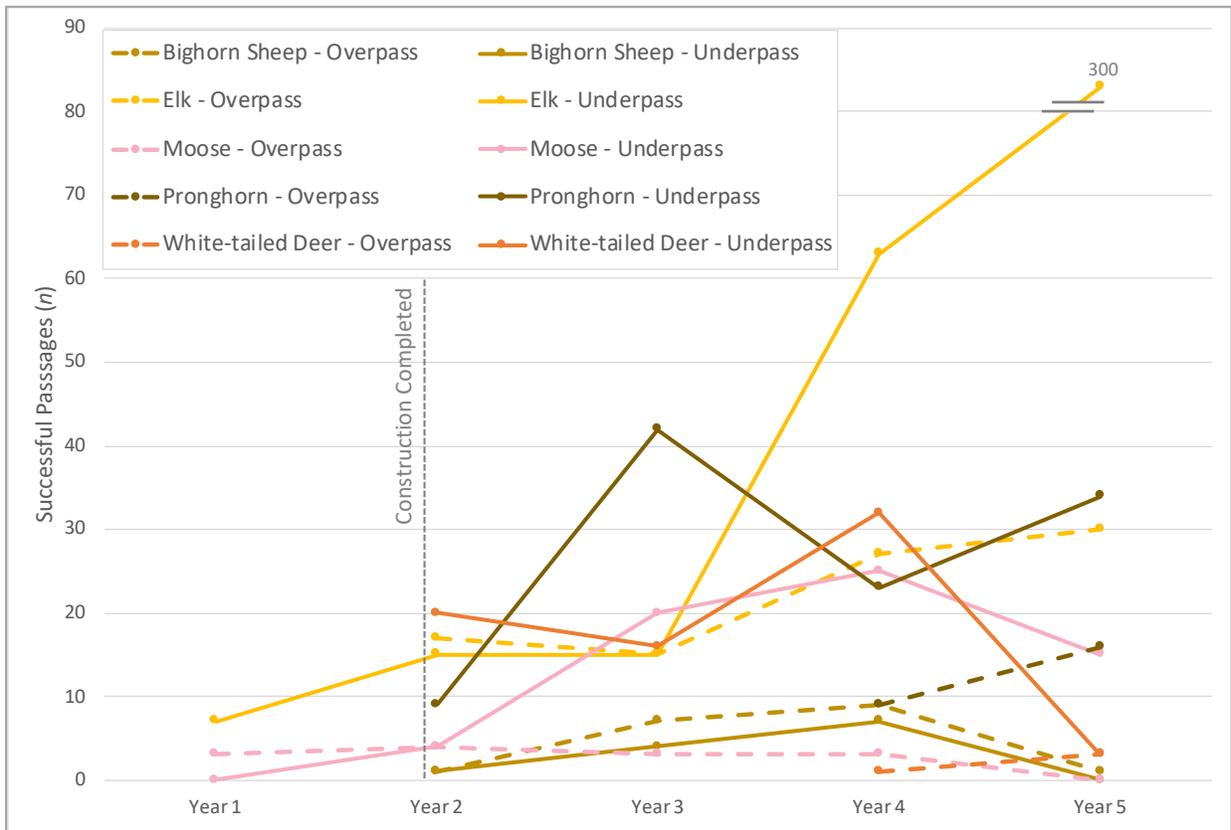
Figure 4-4. Ungulate use of overpasses and underpasses each year of the study.

Each ungulate species used both overpasses and underpasses over the course of the study in varying proportions (Fig. 4-4). Elk and moose were the only ungulate species other than mule deer to use the crossing structures in Year 1, which did not include a summer season. In Year 2, following the completion of construction, each ungulate species was observed at both underpasses and overpasses, except pronghorn and white-tailed deer, which were not documented at an overpass until Year 4. Many of these movements by the different ungulate species were by individual animals, pairs, or small family groups. The exception to this was elk in Years 4 and 5, which were increasingly documented in small herds at the North Underpass.

Elk passages at underpasses was greater than at overpasses but this was driven exclusively by movements at the North Underpass by what was presumed to be the same herd making more regular passages. Moose were also more commonly observed at underpasses but movements at both underpasses and overpasses were documented each year of the study, including during the construction phase (Year 1). The majority of pronghorn passages were males (79%) making solo movements or in pairs at underpass structures. Bighorn sheep passages at overpasses were consistently higher than at underpasses, with a 100% success rate at overpasses versus 63% at underpasses, but the total number of sheep passages was small ($n=30$). White-tailed deer visited the underpasses more than the overpasses and were not observed at all at the two southernmost structures in the study area (Williams Peak Underpass and the South Overpass).

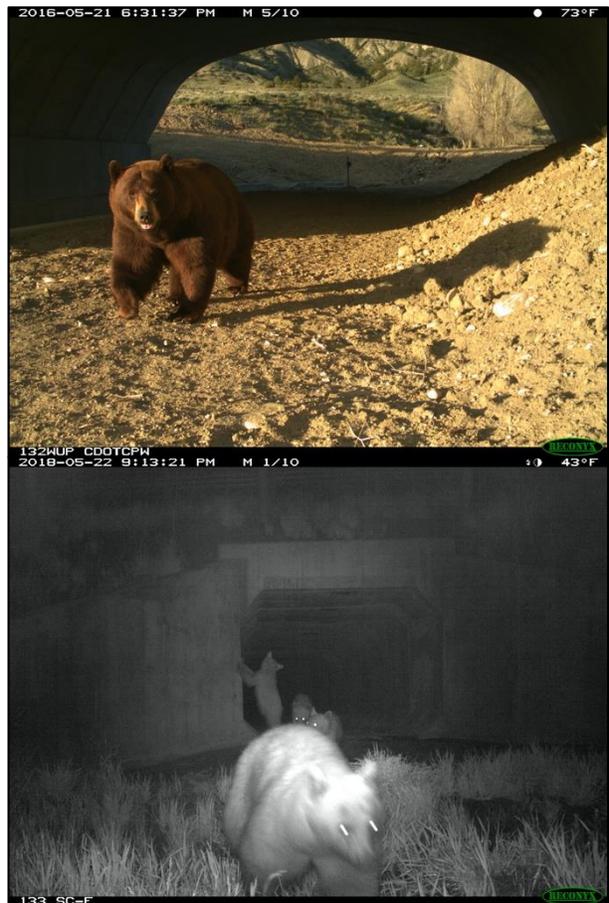
Figure 4-15. Black bear at the Middle Underpass (top) and the BVR Box Culvert (bottom).

Black bear was most likely to use a small culvert or an underpass (Fig. 4-15), with few approaches and successful passages documented at either of the overpasses. These findings are corroborated by research in other locations, which have documented black bear use of a variety of underpass types (Huijser et al. 2016) with a preference for more constricted crossing structures (Clevenger and Waltho 2005, Clevenger and Barrueto 2014). While grizzly bear was also present in these other study areas, even with the absence of this competitor in the SH 9 study area, black bear demonstrated strong preference for the more constricted culverts (7.5-8 foot wide and high).

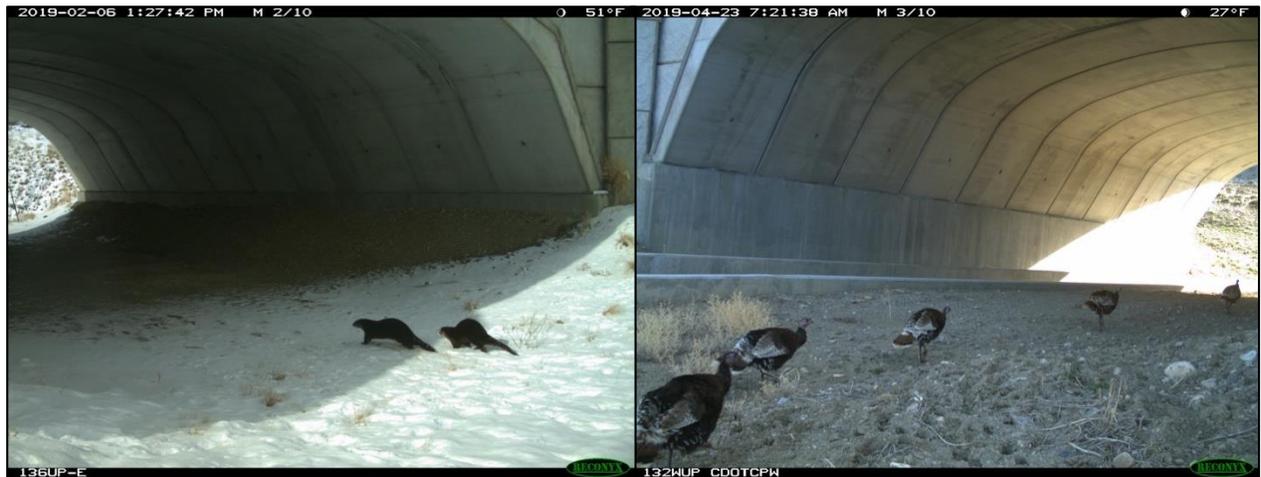
Figure 4-20. Two river otters (left) crossing through the North Underpass and five of six turkeys (right) crossing through the Middle Underpass.

a number of other species, including year-round and seasonal animals (Fig. 4-20). While the total number of successful passages by these other species was much lower than for mule deer, success rates were high (80% or greater) for nearly every species documented, and all species showed stable or increasing crossing structure use during the five-year study period. The multispecies benefits of the mitigation were revealed through comprehensive year-round monitoring over multiple years. Monitoring research in other locations emphasizes the need for long-term studies to fully capture different species adaptation rates to wildlife crossings (Clevenger and Barreto 2014, Gagnon et al. 2011). Ongoing variability and increasing passage rates by many species in this study suggests that wildlife was still adapting to the mitigation and patterns in wildlife use of the crossing structures may continue to evolve over time.

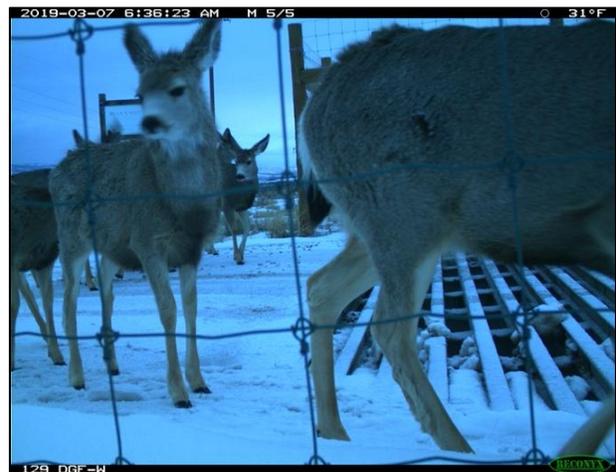
Figure 5-2. Mule deer breaching a wildlife guard by walking on snow packed in between the bars.

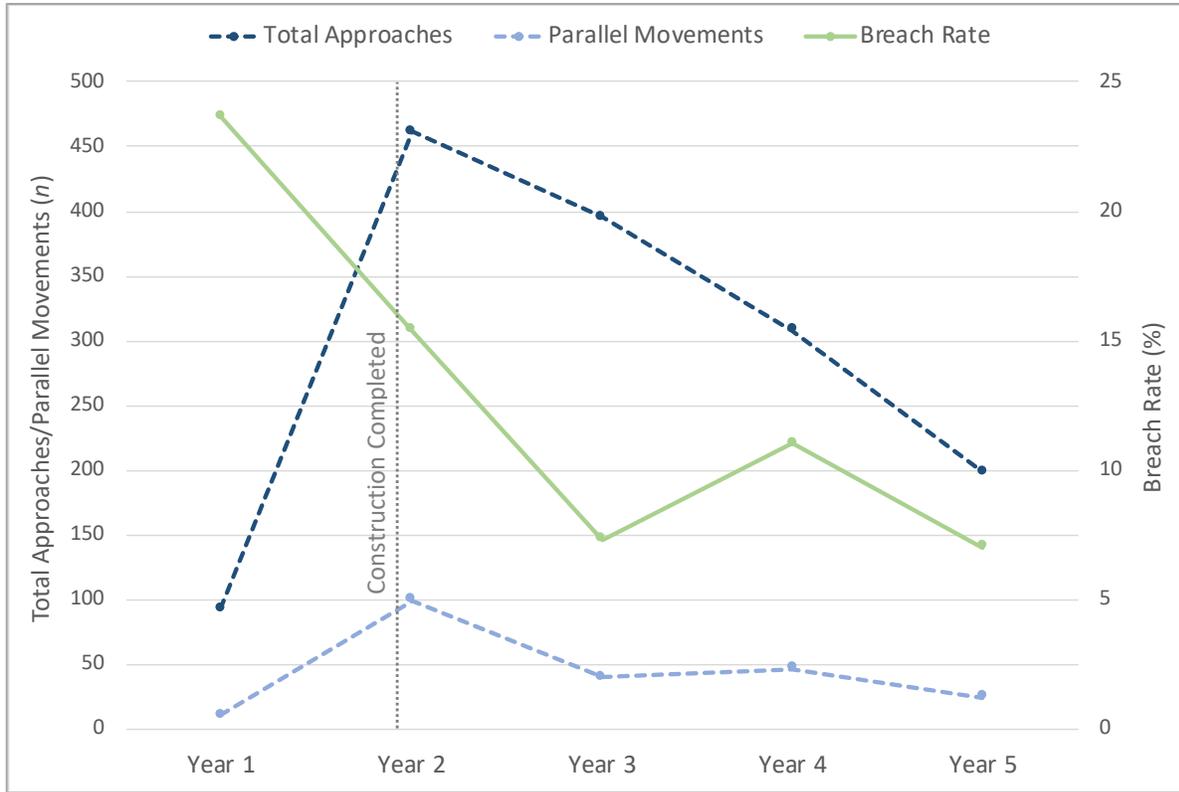
Figure 5-3. Total number of ungulate approaches, parallel movements and breach rate each year of the study.

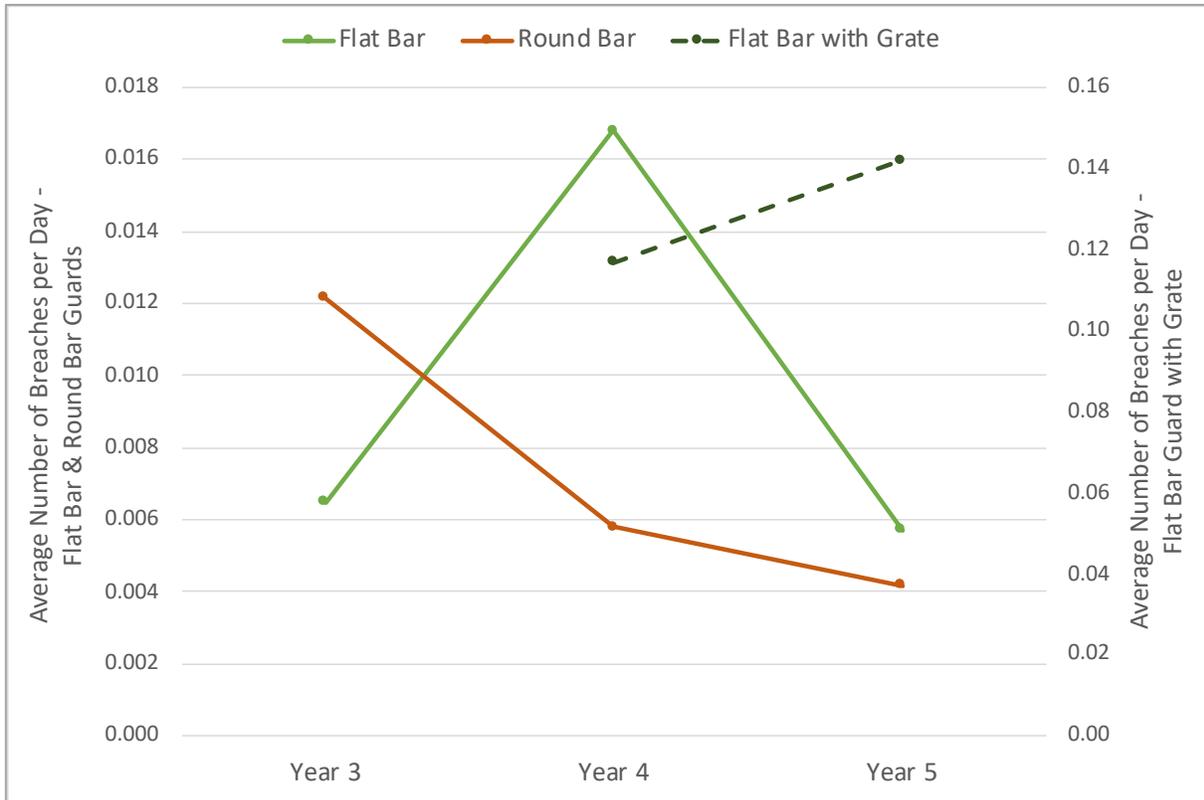
Figure 5-4. Average number of breaches per monitoring day by guard type Years 3-5. During this timeframe, six flat bar guards were monitored, five round bar guards, and one flat bar guard with a pedestrian grate.
