State Highway 9 Wildlife Crossings Mitigation Monitoring

1. Report No. CDOT-2021-01		2. Government Accession No.		3. Recipient's Catalog No.	
4. Title and Subtitle State Highway 9 Wildlife Mitigation Monitoring				5. Report Date March 2021

16. Abstract This research monitored the effectiveness of a wildlife mitigation project on State Highway 9 in Grand County, Colorado. The purpose of the mitigation was to reduce wildlife-vehicle collisions (WVC) while providing permeability for wildlife across the highway. This five-year study used motion activated cameras and analyses of WVC crash and carcass data to evaluate mitigation effectiveness. The research documented 112,678 mule deer successful passages and a success rate of 96% across the seven structures. In addition to mule deer, sixteen other wildlife species successfully used the crossing structures. The wildlife crossings and fencing mitigation helped decrease WVC crashes by 92% and carcasses by 90% relative to preconstruction levels. Implementation Initial findings of the study were used to inform mitigation designs in the second construction phase, resulting in the addition of new escape ramp and wildlife guard designs. The fi

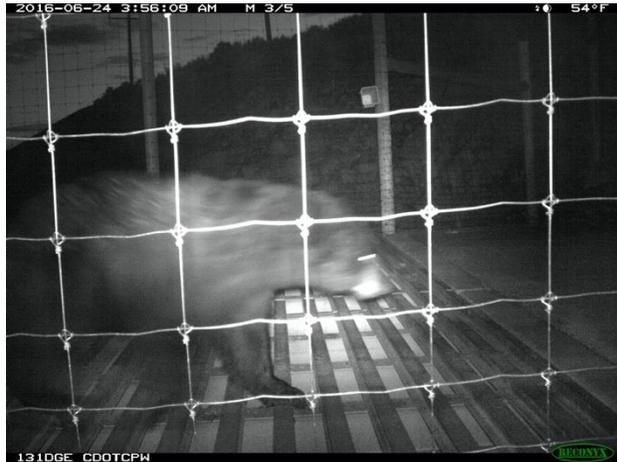
Figure 5-5. Black bear breaching a wildlife guard from the ROW side to the habitat side.

by breaching the guards. Bears (Fig. 5-5), canids, and felids were more likely to breach the guards in both directions, with 33% of breaches originating from the right-of-way side back to the habitat side of the fencing ($n=132$).

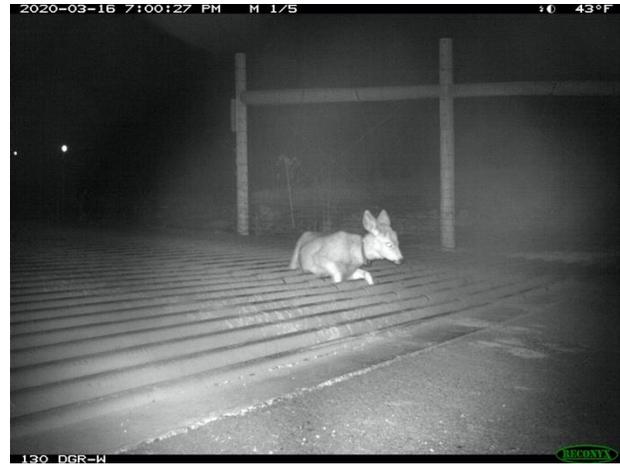
Figure 5-6. Mule deer that fell between the bars of a wildlife guard.

Mitigation projects across western states have employed a number of different wildlife guard designs, ranging from double cattle guards (e.g., Cramer and Flower 2017, Gagnon et al. 2020) to wildlife guards with a grid pattern (e.g., Allen et al. 2013, Cramer and Flower 2017, Peterson et al. 2003). Regardless of guard type, the SH 9 mitigation project incorporated several important design features based on lessons learned from other states. These features include a guard length (the distance animals must traverse to breach a guard) of at least 16 feet (Gagnon et al. 2020); and the absence of a concrete ledge framing the outside of a guard vault and the elimination of a center concrete strip supporting the two halves of the guard, both of which wildlife have quickly learned to exploit to breach a guard (Cramer and Flower 2017, Gagnon et al. 2020, Huijser et al. 2016). In addition, following observations of ungulates breaching the guards by walking on the support beams in Year 1, angle iron was added to the support beams of all the new guards constructed in Phase 2 to discourage these types of breaches. The angle iron discouraged some breaches, but mule deer still breached round bar guards with the angle iron by walking on the support beams on six occasions. To prevent possible injuries to ungulates that may fall in between the bars of a wildlife guard, Gagnon et al. (2020) experimented with placing welded black plates inside the guards to mimic the appearance of a cattle guard but found that they quickly became ineffective. While there was no evidence of wildlife injuries as a result of animals falling between the bars on SH 9, the potential for this type of injury remains a concern (Fig. 5-6). At one guard across a private driveway, a domestic horse became trapped in a flat bar guard and had to be euthanized.

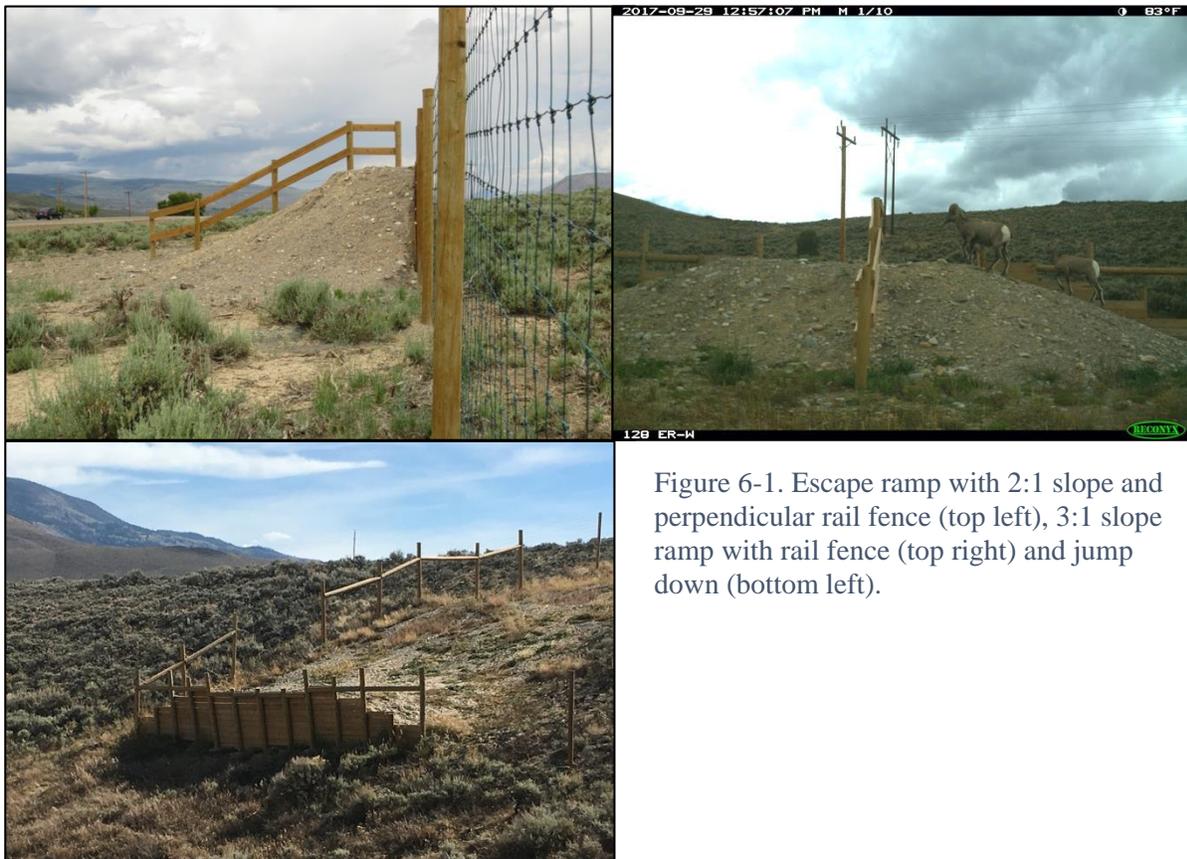
Figure 6-1. Escape ramp with 2:1 slope and perpendicular rail fence (top left), 3:1 slope ramp with rail fence (top right) and jump down (bottom left).

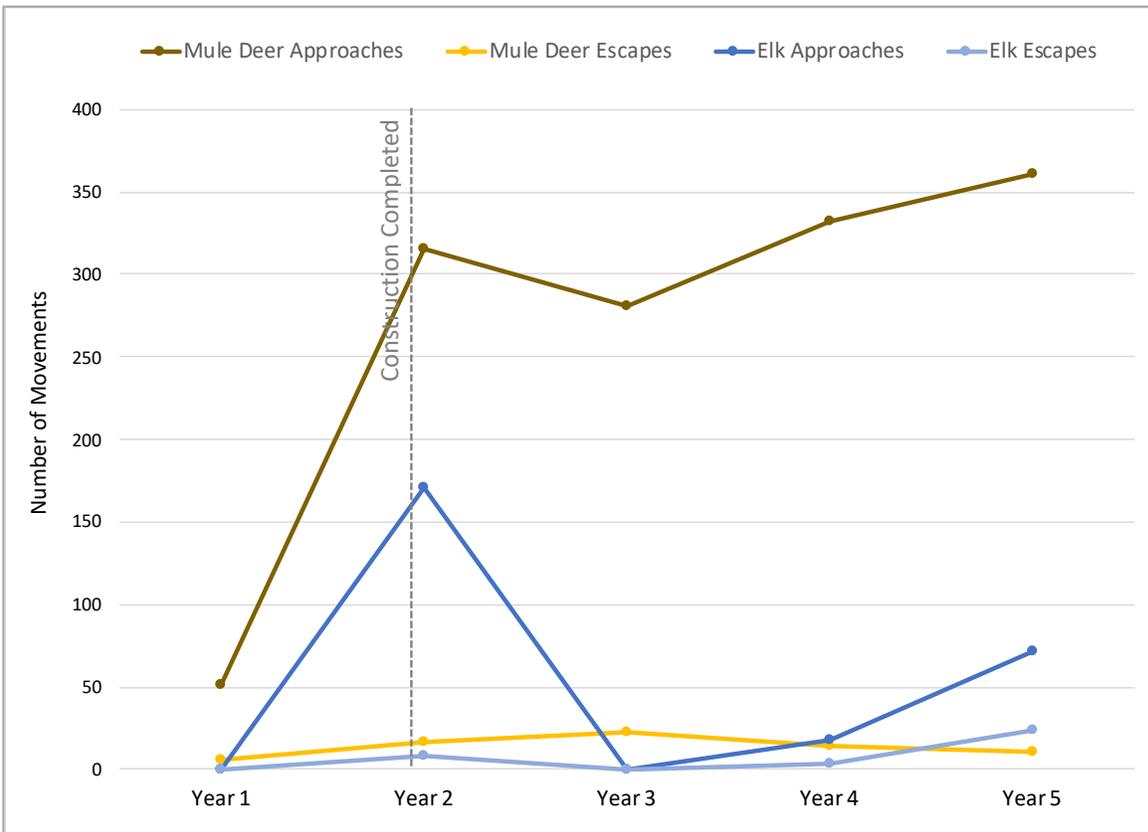
Figure 6-2. Elk and mule deer total approaches and successful escapes (jump downs) each year of the study.

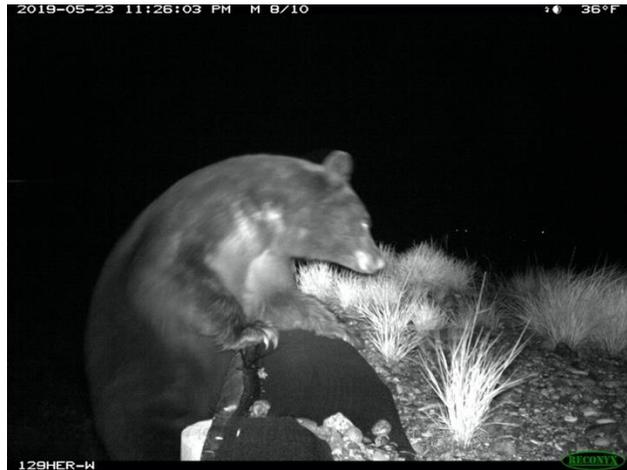
Figure 6-3. Black bear climbing up the back side of an escape ramp to enter into the ROW.

Both mule deer ($n=4,488$) and elk ($n=370$) were documented moving parallel along the fence line on the habitat side of the ramps. On a few occasions, elk were recorded looking up at the fence opening at the top of the ramp, but no mule deer or elk attempted to jump up from the habitat side of a ramp into the fenced ROW. The only species documented jumping or climbing up from the backside of the ramp to enter into the ROW were bobcat ($n=5$) and bear ($n=1$; Fig. 6-3).

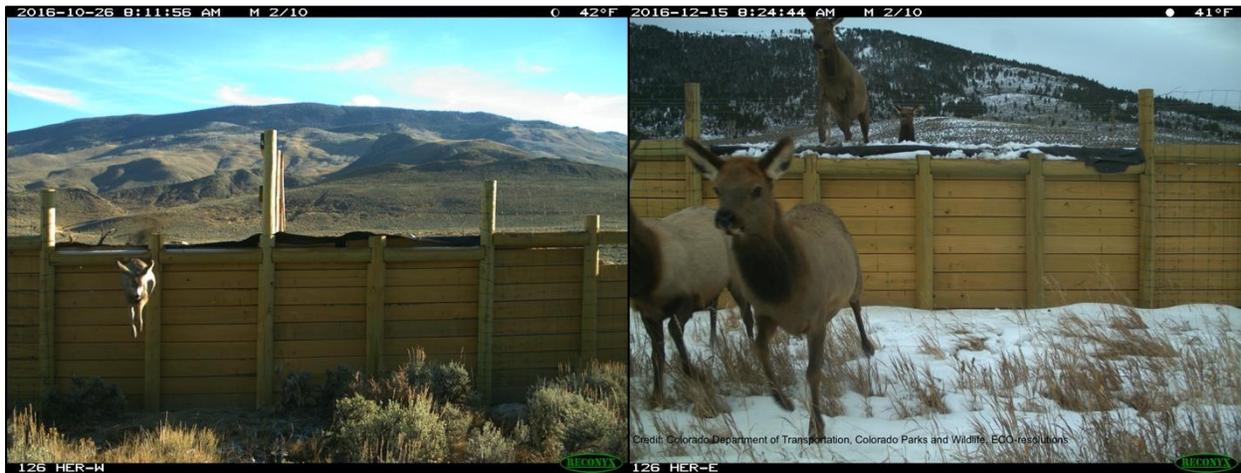
Figure 6-4. Deer (left) and elk (right) making successful escapes off the escape ramps.

The objective of a wildlife crossings system with continuous fencing and wildlife guards is to prevent wildlife from entering into the fenced ROW. Nevertheless, no mitigation system is perfectly tight at all times and escape ramps are an important component, allowing animals that do become trapped in the ROW a means of escaping back to the habitat side of the fencing (Gagnon et al. 2020, van der Ree et al. 2015). On SH 9, the escape ramps were more successful in allowing elk to escape the ROW (23%) than mule deer (10%; Fig. 6-4).

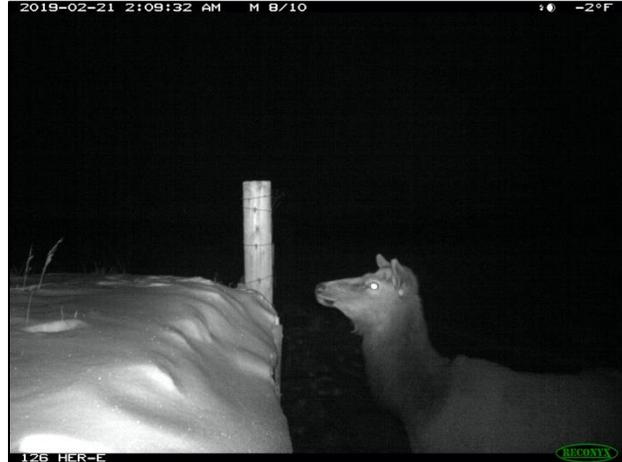
Figure 6-5. Elk investigating a ramp from the habitat side of the fence.

No ungulates were documented attempting to jump from the habitat side of the fence into the ROW via the fence gap at the top of an escape ramp, despite the high number of animals documented walking along the fence line and, on occasion, looking up at the top of the ramp (Fig. 6-5). This 100% repel rate is likely due to the high ramp heights, which ranged from 65-88 inches. While these ramp heights were effective in keeping wildlife from breaching into the ROW via the escape ramps, they were also a factor in the low escape rates observed, demonstrating the need to optimize ramp height to increase successful escapes while continuing to prevent breaches at the escape ramps.

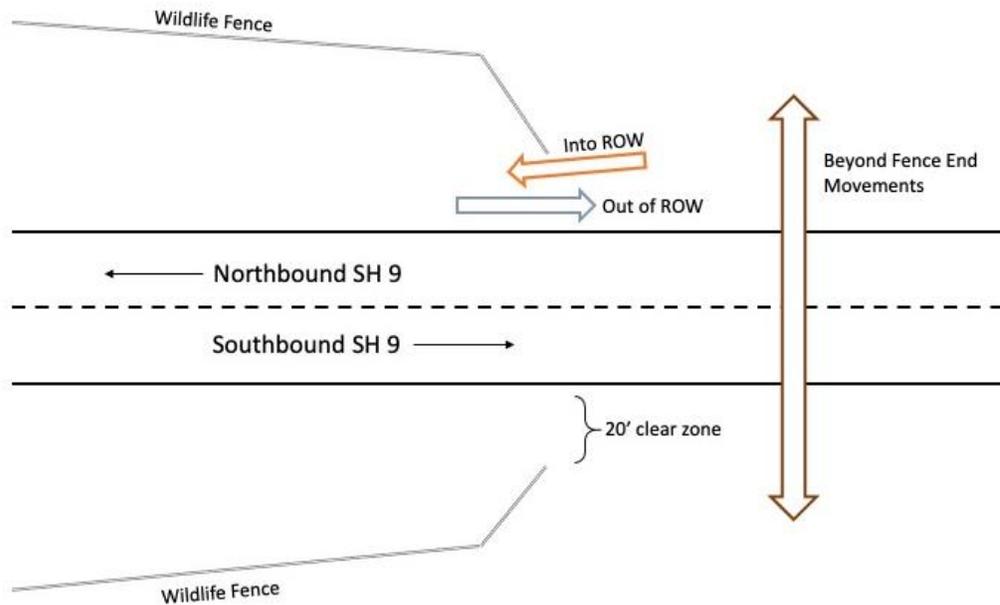
Figure 7-1. Diagram of types of the three types of wildlife movements at the south fence end.

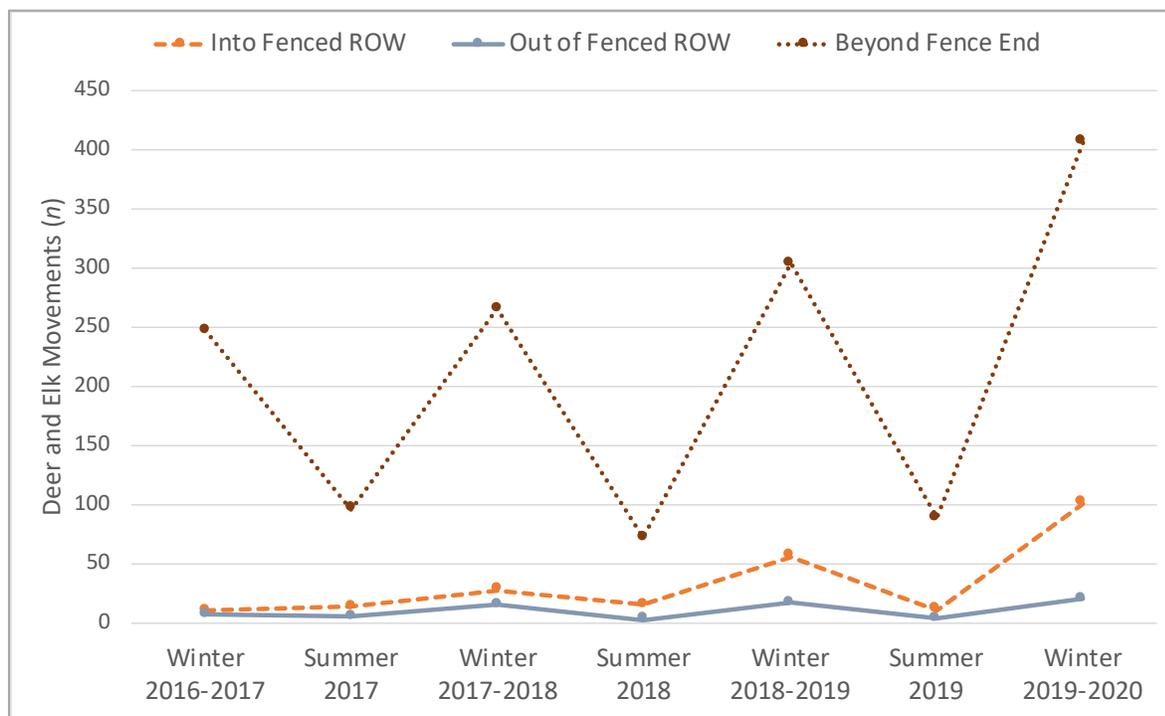
Figure 7-2. Three types of movements at the south fence end by deer and elk each season post construction.

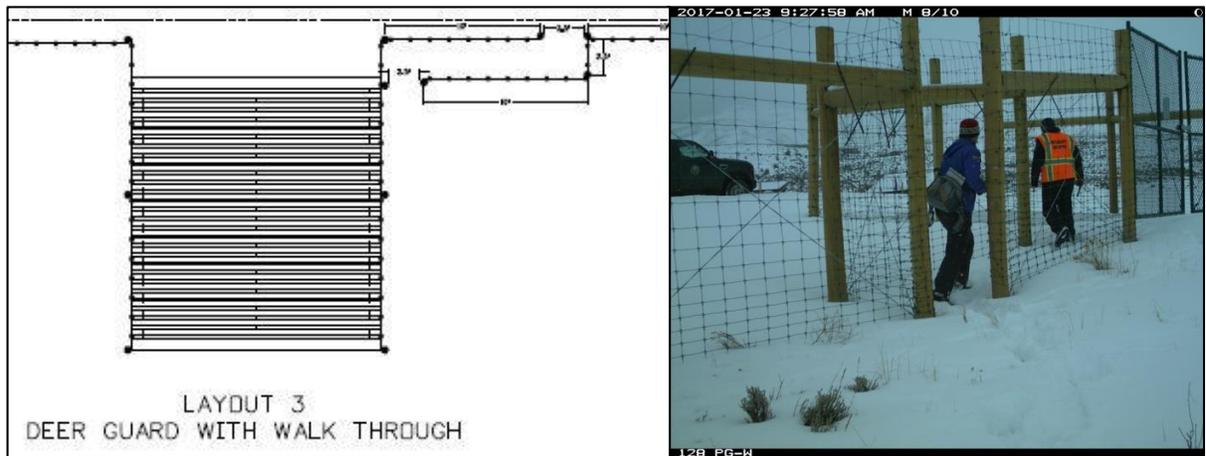
Figure 7-3. Left: CDOT design for pedestrian access point adjacent to a wildlife guard. Right: People walking through a pedestrian access point.

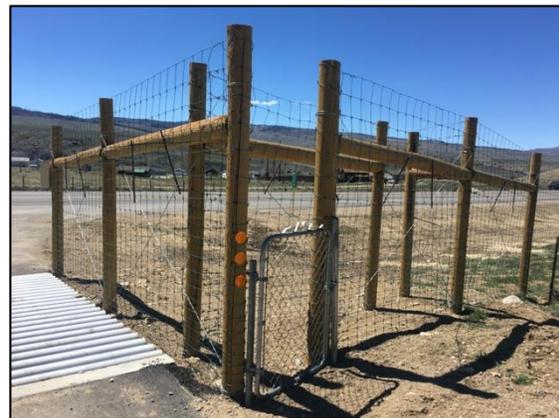
Figure 7-4. Pedestrian access point outfitted with a swing gate.

At the onset of Year 3 (summer 2017), CPW determined that the pedestrian access point design was insufficient in deterring wildlife breaches into the ROW and posed a risk to motorists that could be eliminated by closing the entrances with swing gates (Fig. 7-4). Monitoring ceased at these locations with the addition of the swing gates.

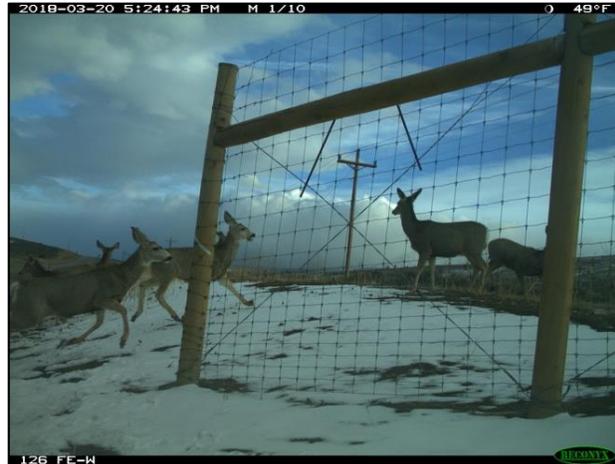
Figure 7-5. Mule deer attempting to cross SH 9 at-grade just beyond the south fence end.

Ongoing and increasing ungulate activity at the south fence end indicate that the fence end design is not preventing wildlife from entering into the ROW around the fence end and that the project may not fully mitigate wildlife movements across SH 9 (Fig. 7-5). These findings are consistent with CPW's understanding of wildlife movements in the lower Blue River valley prior to the mitigation construction. Due to funding constraints and the lack of a suitable location

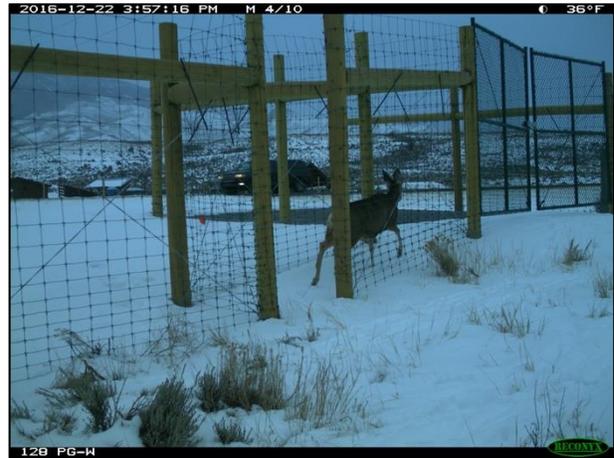
Figure 7-6. Mule deer breaching into the ROW via a pedestrian access point.

The breach rate at pedestrian access points was 11% for mule deer ($n=32$) and 4% for elk ($n=2$) in the two years during which monitoring was conducted at these locations. While these numbers appear low, these breaches into the fenced ROW may have been completely eliminated once CPW retrofitted them with swing gates at the summer of 2017, thereby potentially ending the possibility of WVC as a result of breach events at these locations. These findings, coupled with the findings from Montana on a Y-shaped pedestrian access point (Huijser et al. 2016), indicate that current designs for fence mazes or other openings in the fence may not be sufficient for preventing wildlife breaches into the ROW at pedestrian access points (Fig. 7-6).

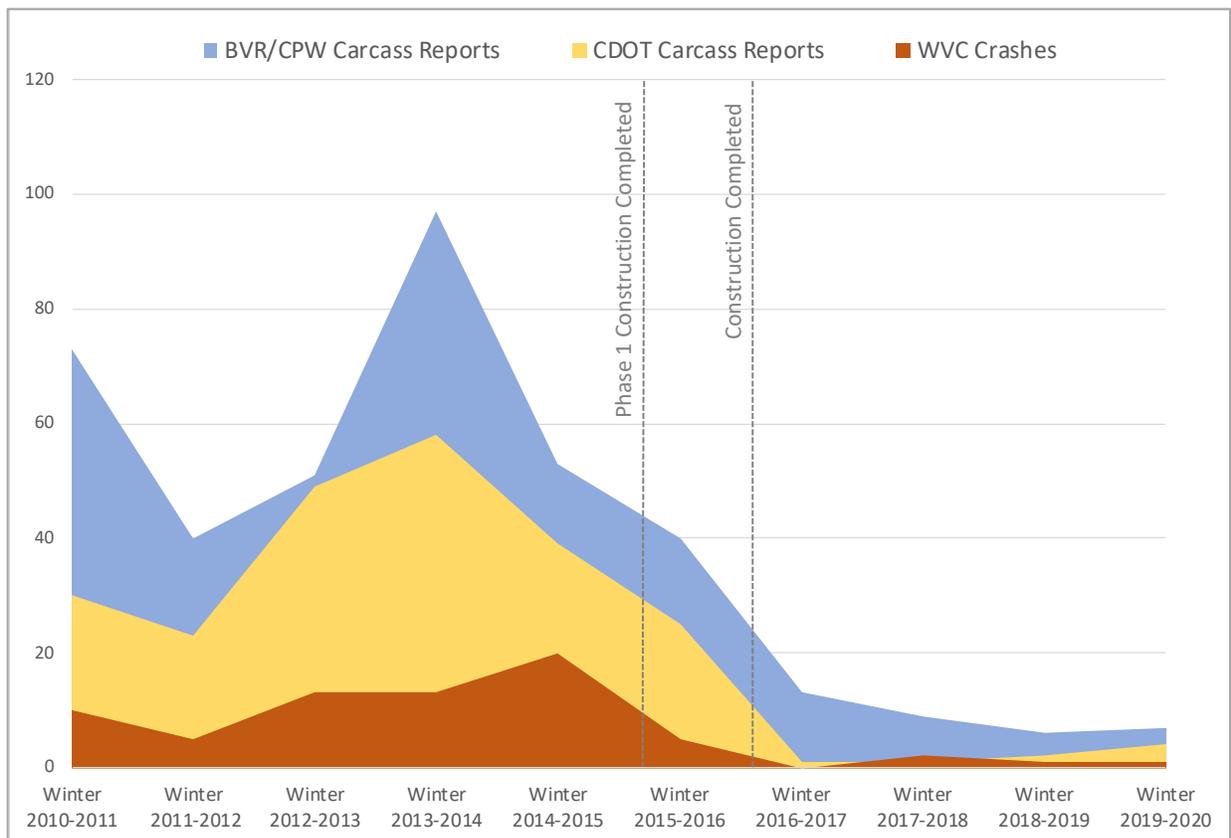
Figure 8-3. Pre- and post construction WVC carcasses and crashes reported each winter as documented by BVR/CPW carcass reports, CDOT carcass reports, and CDOT crash reports.

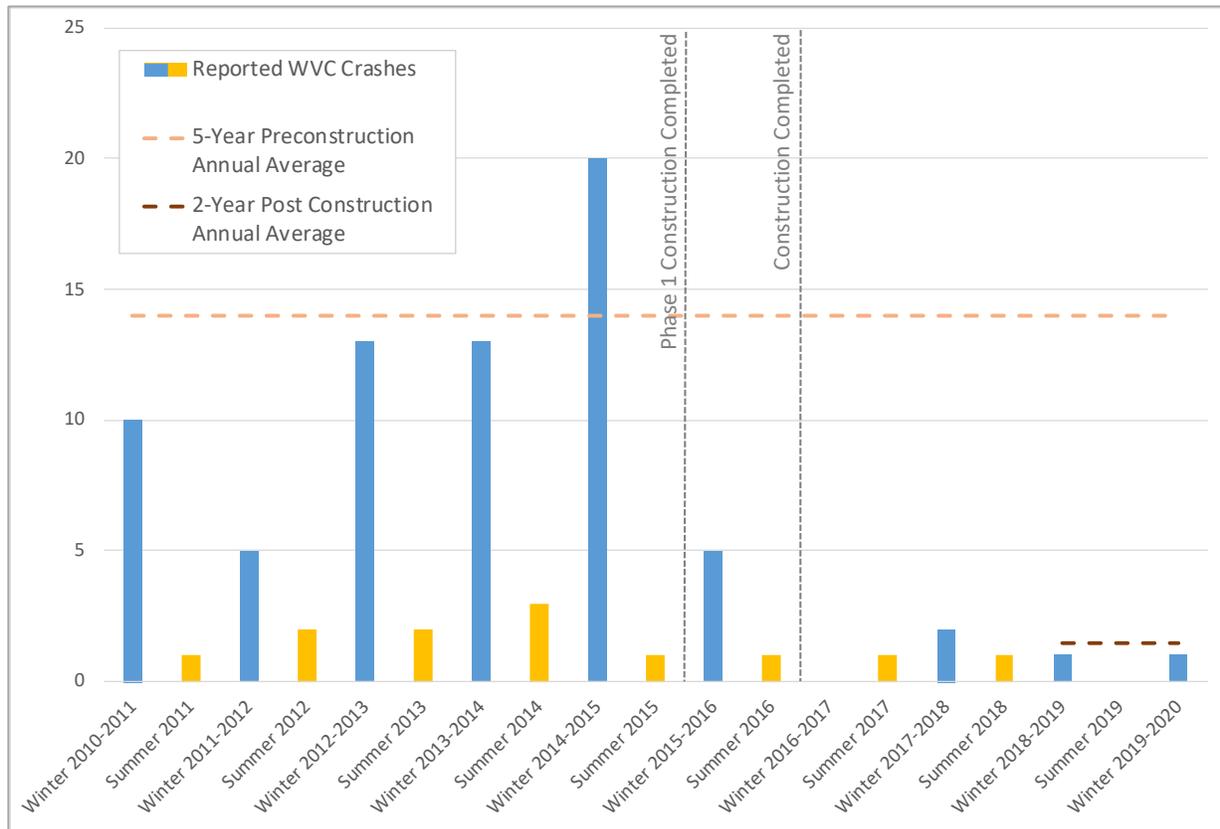
Figure 8-5. Wildlife-vehicle collision reported crashes by winter and summer seasons. The five-year preconstruction annual average was 14 crashes and the final two-year post construction annual average was 1.5 crashes.

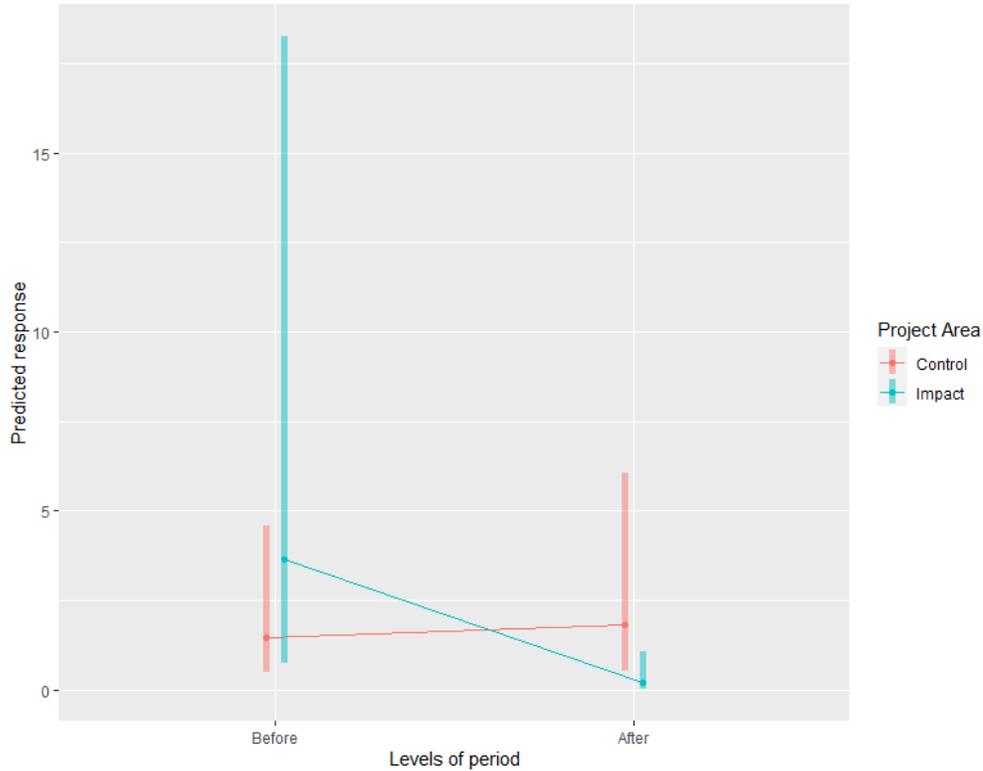
Figure 8-6. Estimated mean number of WVC carcasses per mile by project area and period, with 95% confidence interval.

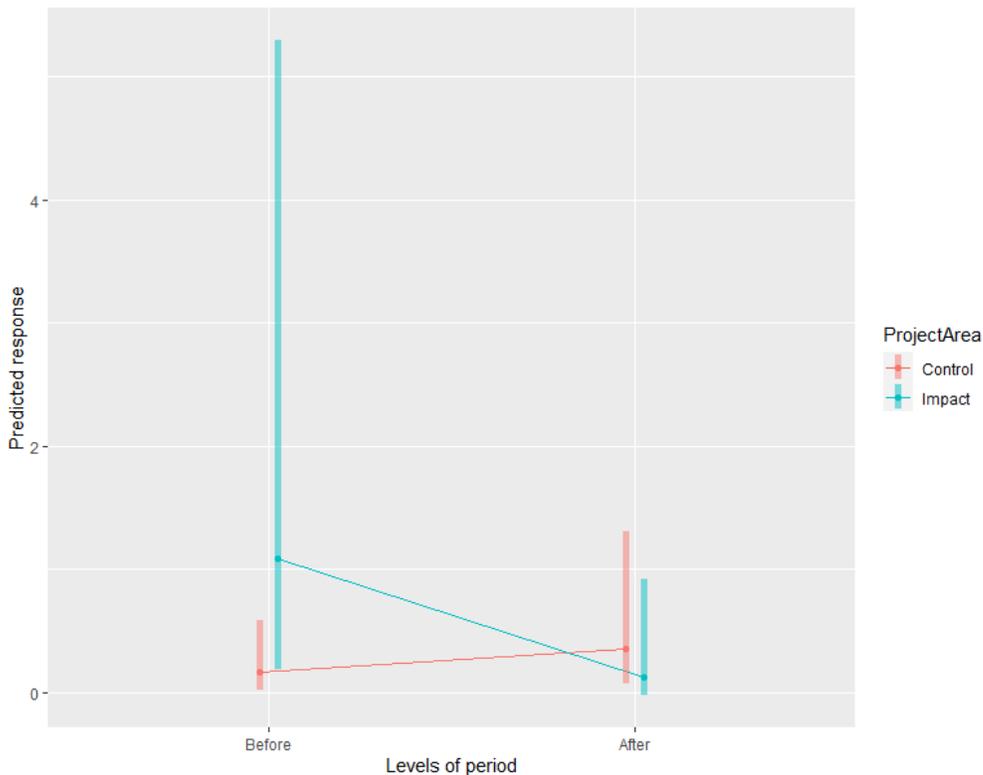
Figure 8-7. Estimated mean number of WVC crashes per mile by project area and period, with 95% confidence interval.

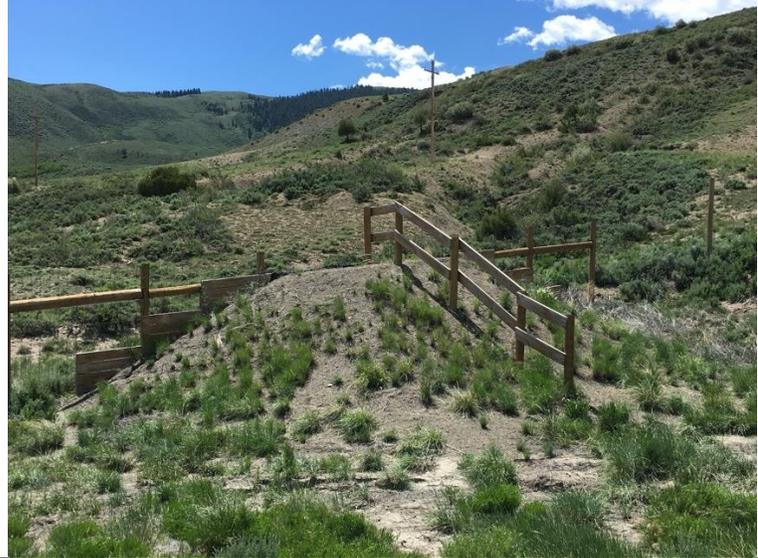
Escape Ramp – 3:1 slope without perpendicular rail fence

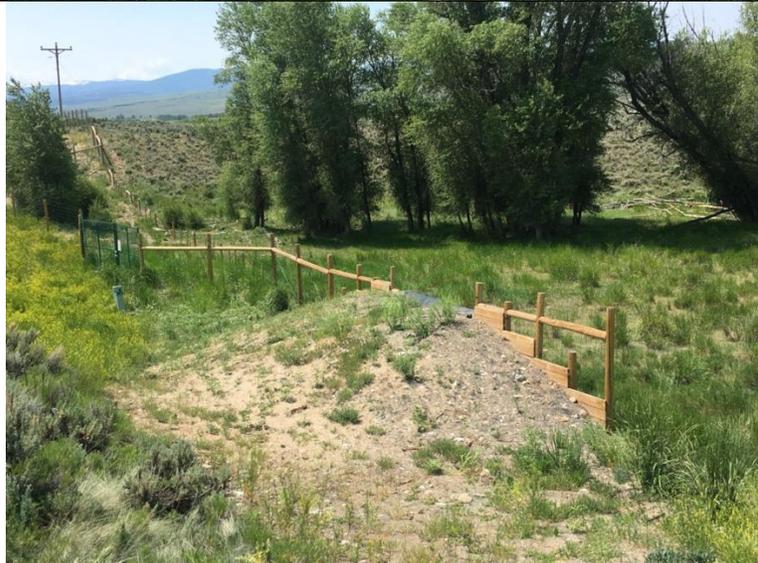
Escape Ramp – Jump Down
