STATE HIGHWAY 9 WILDLIFE CROSSINGS MONITORING – YEAR 2 PROGRESS REPORT

December 2015 through April 2017

Study Number 115.01

March 2018

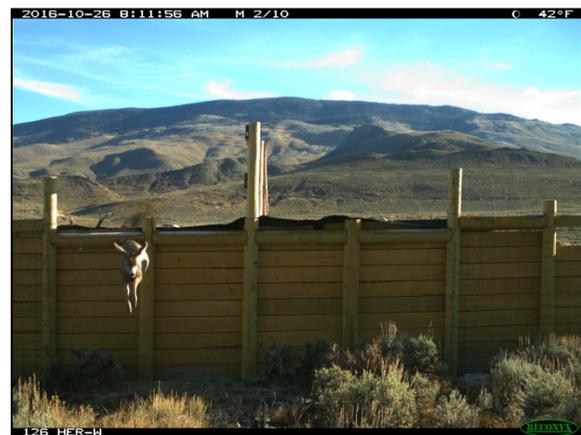
Escape rates for mule deer were low across locations. In total, mule deer were documented making successful escapes on 22 occasions (11% escape rate) and elk were documented on eight occasions (9% escape rate). Five ramps had escape rates of 0%. The highest escape rates for mule deer were at the West Fence End Escape Ramp (40%; 3:1 slope with rail fence – Fig. 31) and the Spring Creek Escape Ramp (33%; 3:1 slope without rail fence). Elk were mainly documented at just one ramp location, the East Fence End Escape Ramp (n=162; 3:1 slope with rail fence). The escape rate for elk at this location was 8%. These escapes are all accounted for in a single event that occurred in January 2017, in which this group of elk was documented entering into the fenced right-of-way from the south fence end. After two attempts ascending the ramp, the entire group

Figure 31. Successful mule deer escape at the West Fence End Escape Ramp.

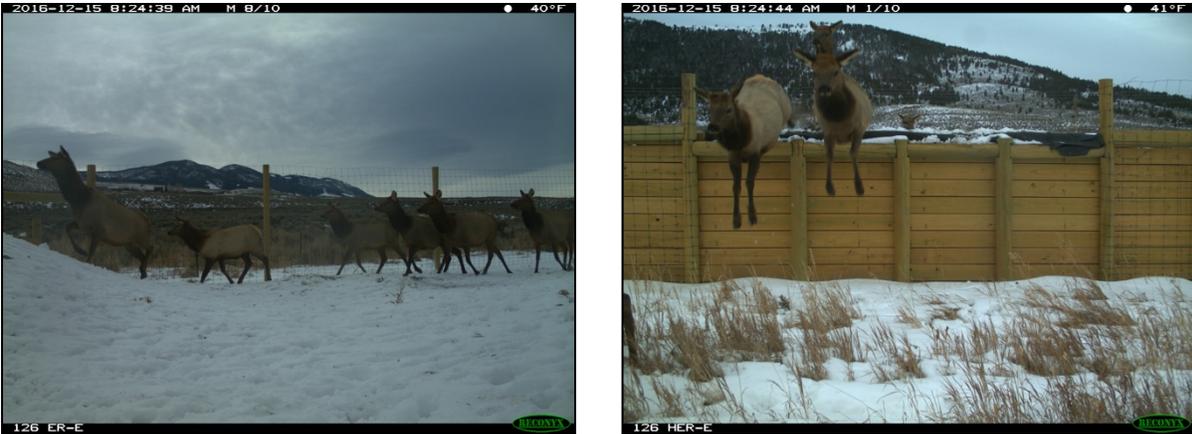
ultimately jumped down from the ramp to the habitat side (Fig. 32). This example underscores the value of escape ramps near fence ends.

Figure 32. Group of elk ascended the East Fence End Escape Ramp and after several attempts successfully escaped to the habitat side.

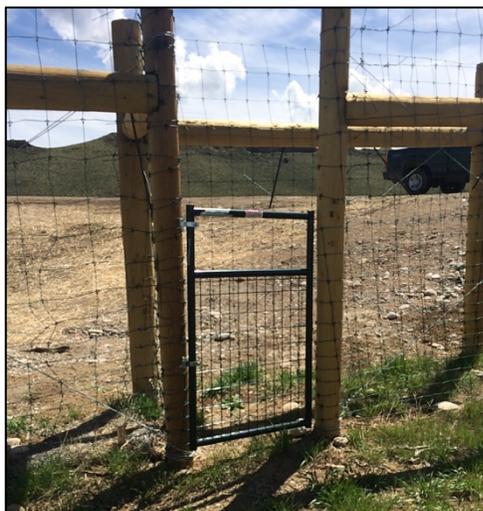
Figure 36. Pedestrian walk-through gate equipped with swing gate.

Since the onset of this study, 32 breaches were made by mule deer and 2 by elk out of a total of 304 and 47 movements, respectively. CPW determined that these breaches – and potential WVC – could be eliminated all together with the installation of swing gates across the gate openings. By September 2017, all of the walk-through gates were equipped with additional swing gates to block ungulates (Fig. 36) and monitoring cameras were removed from these locations. Consequently, performance measure number 12, which was established to determine the effectiveness of the pedestrian walk-through gates will no longer be evaluated.
